This history was prepared by
the King of Prussia Historical Society

History of the Moore-Irwin House 2: Irwin, Okie & After

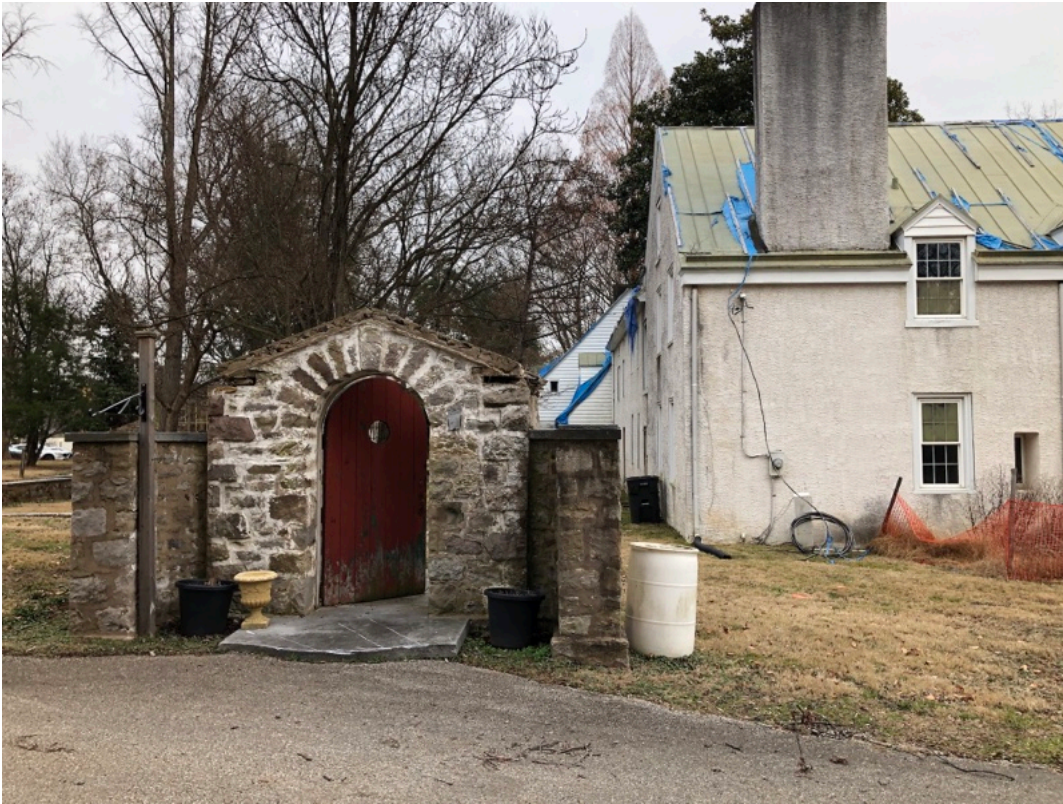
Fig. 6. The entrance gatehouse as it appears today. Current photo.

Plans were drawn up for an entrance gate house on July 1, 1918, which still stands today (figs. 5 & 6.)

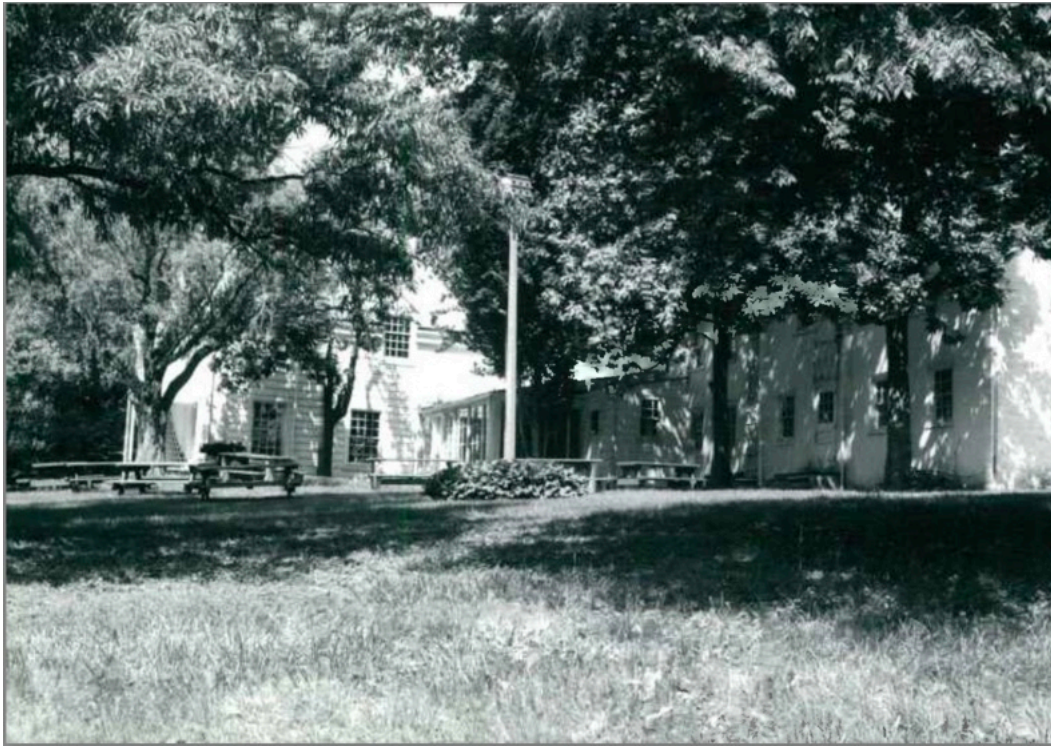
Fig. 11. The south side of the house, looking northwest. The 1932 addition is on the left; the sun room (since removed) is in the center of the photo. Photo by Dave Broida in 1979.

Altogether, there are 64 letters and dozens of architectural plans in the R. Brognard Okie Architectural Papers that have to do with the 1932 remodeling and expansion of the house. The main change was the addition of a large “ell” shaped wing to the southern side of the house on the west side (figs 9 & 10.) In addition, an enclosed sun room was added between the new wing and the southern face of the 1820 portion of the house, as well as an enclosed porch on the northern side of the house (figs. 119 & 12.) (The sun room and the enclosed porch have since been removed.)

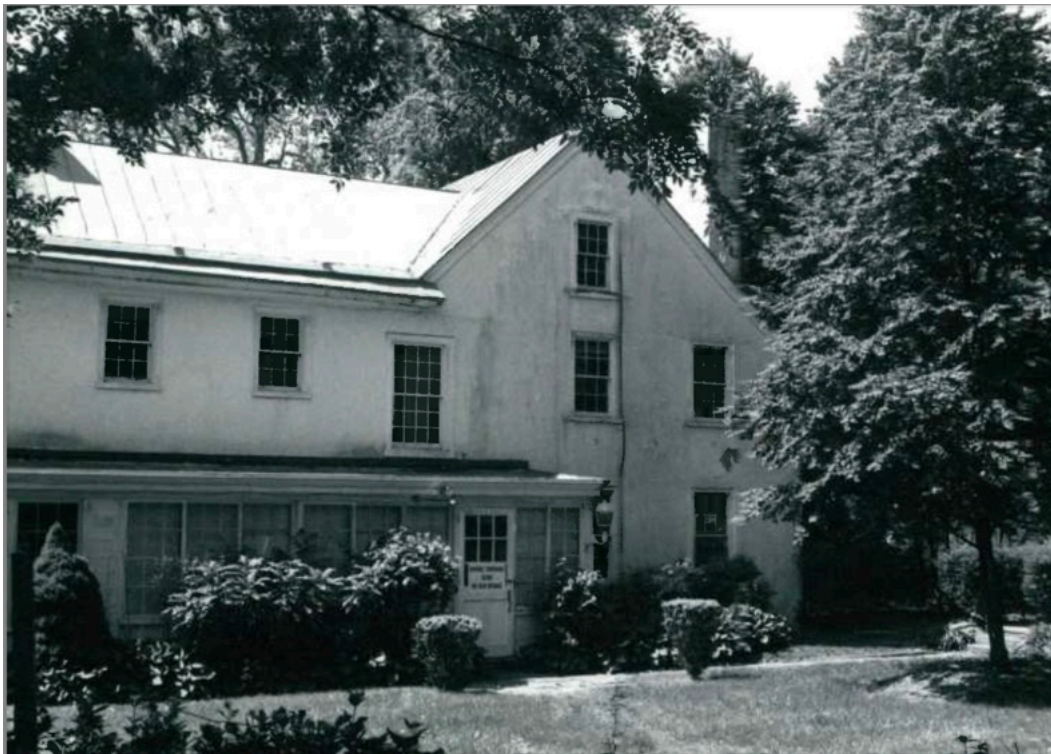
Fig. 12. The north side of the house showing the enclosed porch (since removed.). Photo by Dave Broida in 1979.

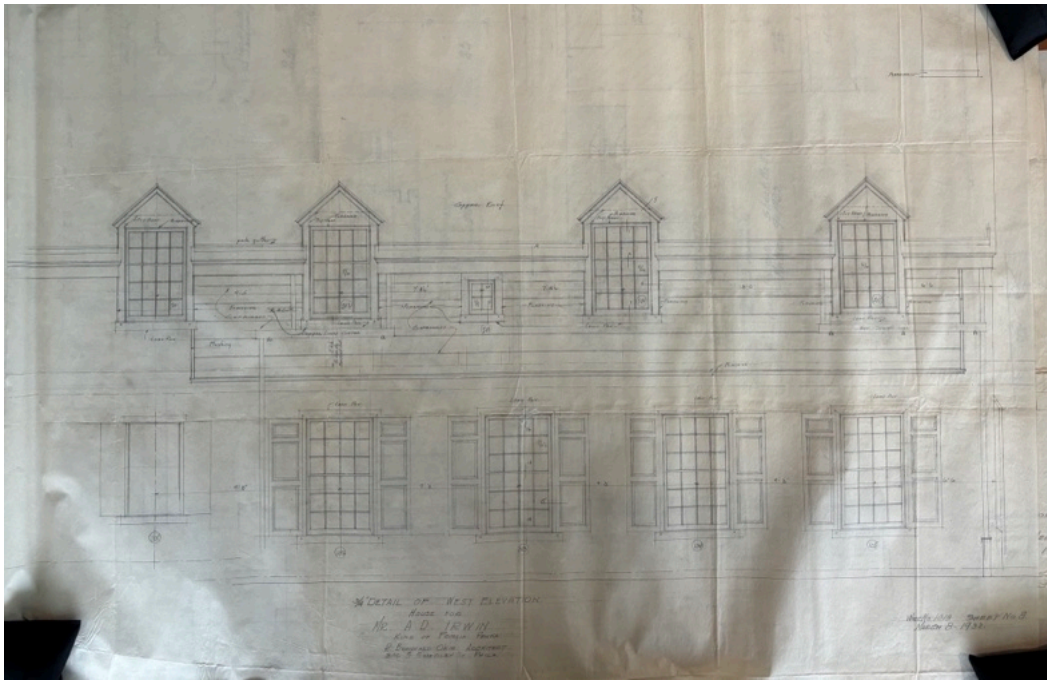
Fig. 13. West side elevation drawing of the addition. From the R. Brognard Okie Architectural Papers. Photographed at the Pennsylvania State Archives in Harrisburg.

The extension of 1820 part of the house southward entailed a change in the roofline. Okie designed a cross-gable 90 degrees from the original roofline. This gave the house an additive look, typical of Okie’s style. The extension also had dormer windows that broke the roofline - another signature element of Okie’s style, as are the oversized chimneys (figs. 13-18.)

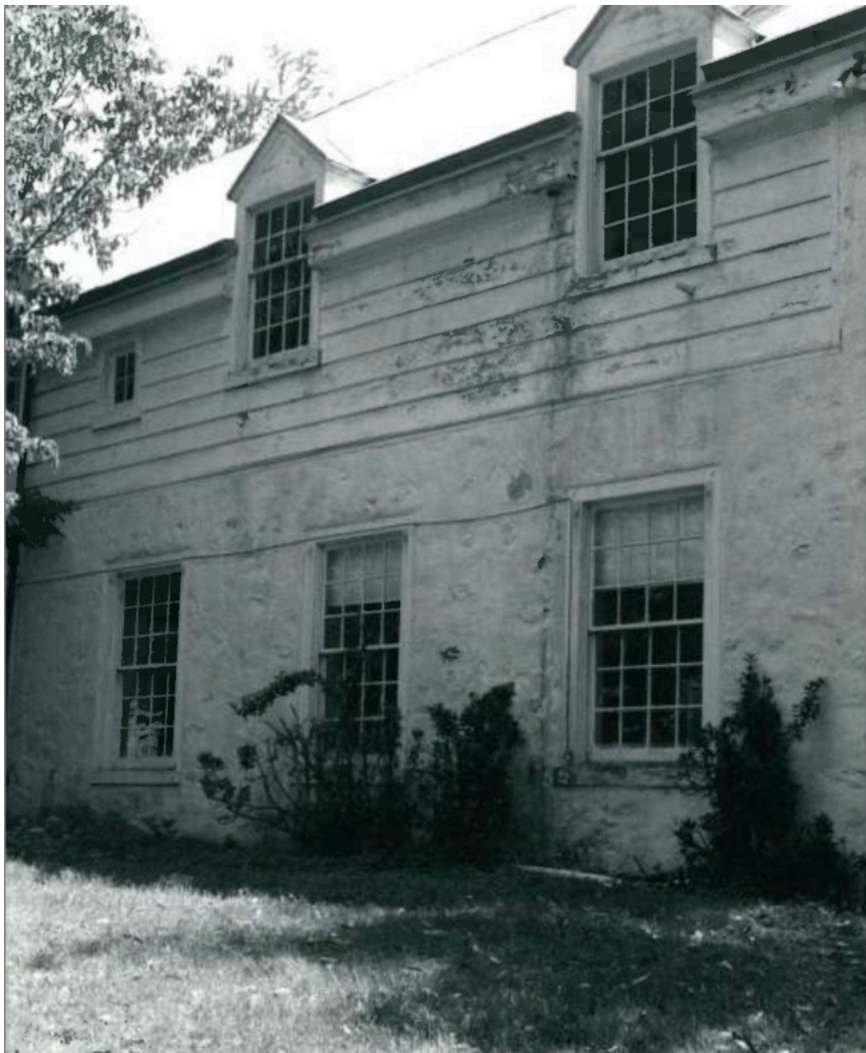
Fig. 14. The west side of the 1932 addition showing the dormer windows that break the roofline. Photo by Dave Broida in 1979.

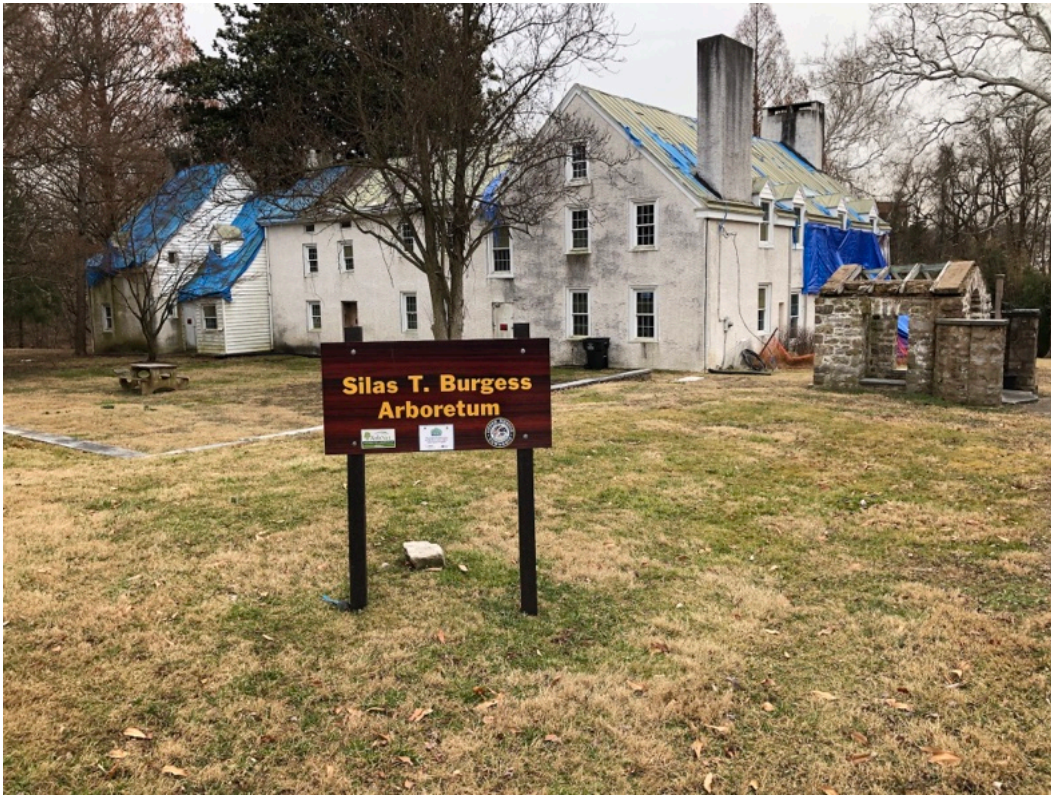
Fig. 15. The north and west side of the house, looking southeast. On the right is the Okie addition with dormer windows that break the roofline and cross-gabled roofline. The large chimneys are also visible. Current photo.

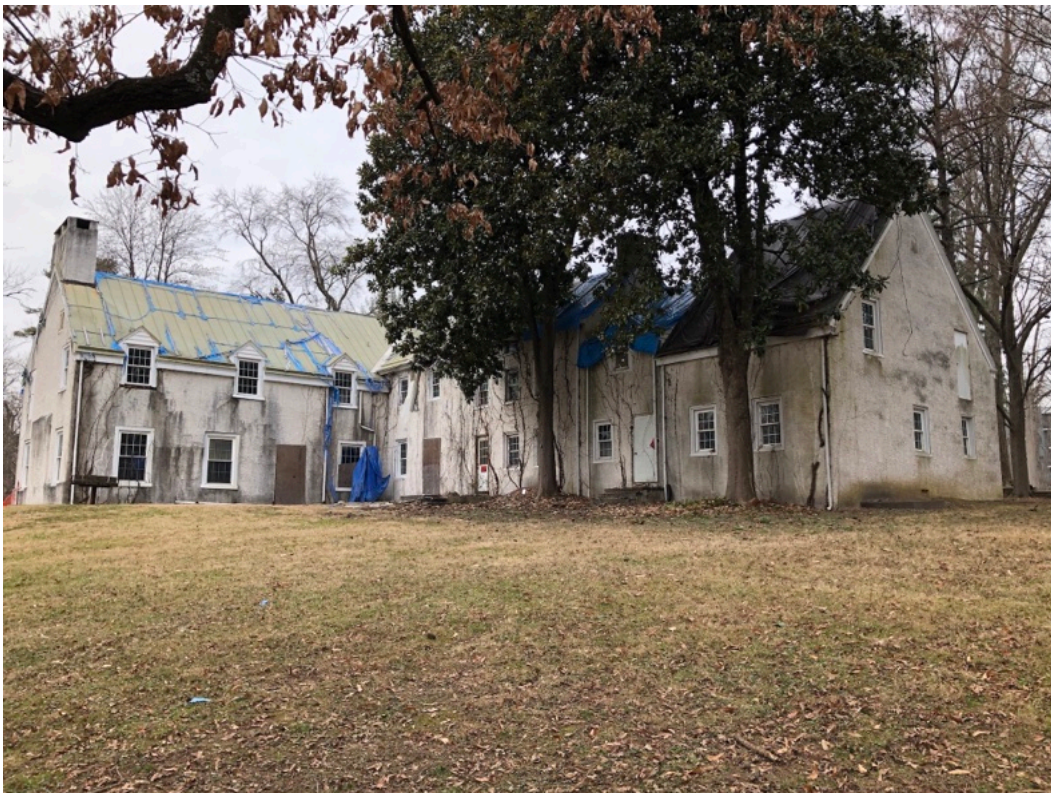
Fig. 16. The south and east side of the house, looking northwest. On the left is the Okie addition with dormer windows that break the roofline. Current photo.

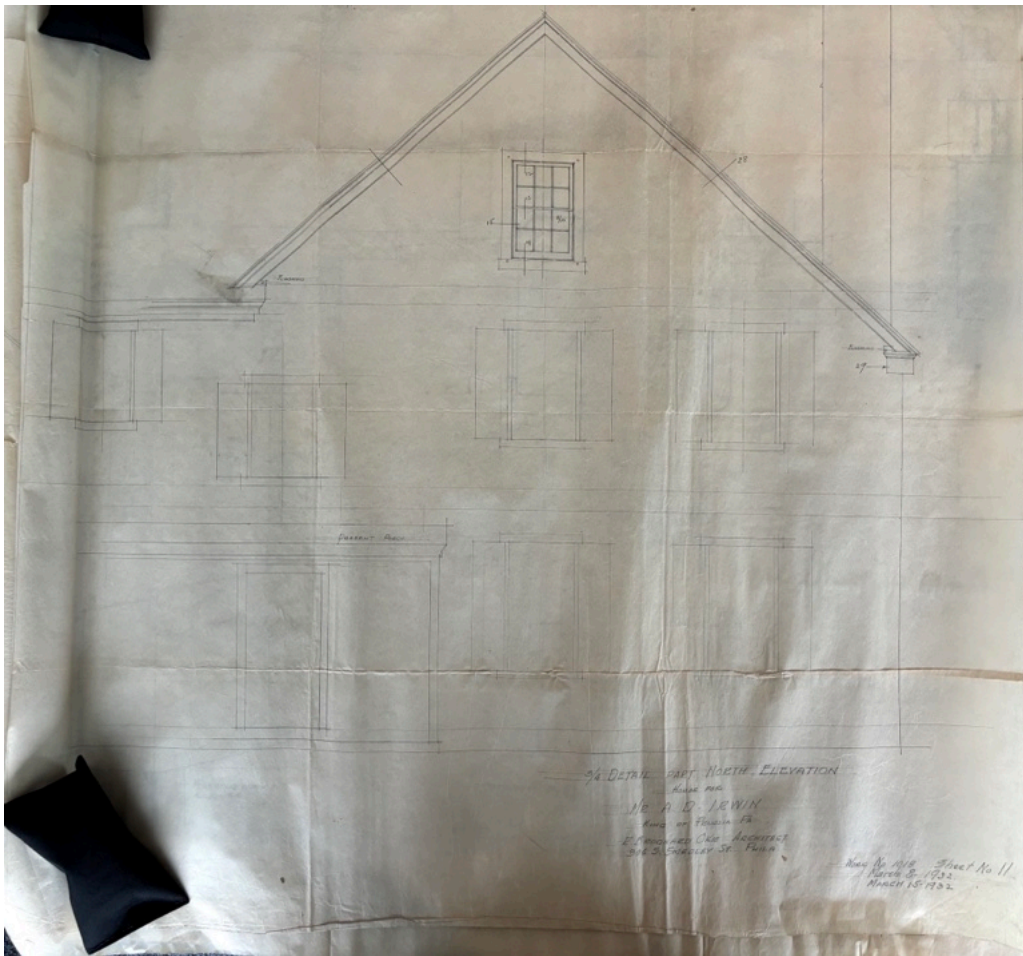
Fig. 17. North side elevation drawing, showing the gabled roof. From the R. Brognard Okie Architectural Papers. Photographed at the Pennsylvania State Archives in Harrisburg.

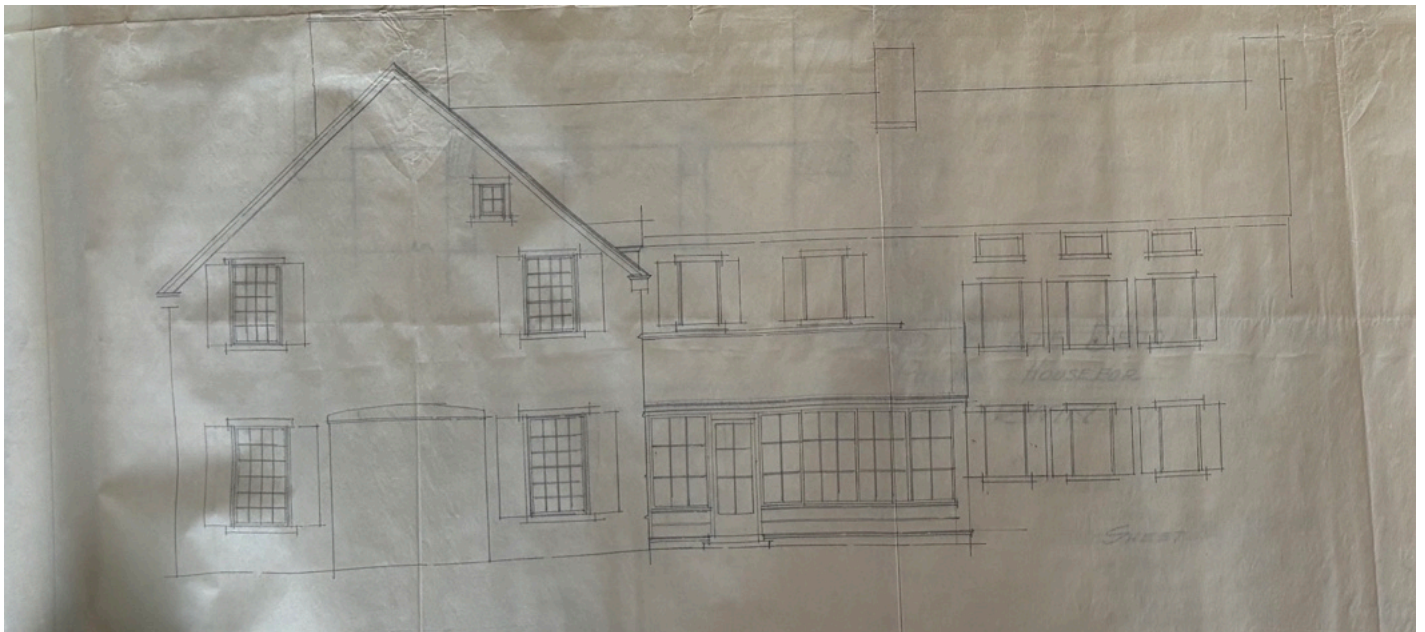
Fig. 18. South side elevation drawing, showing the gabled roof. From the R. Brognard Okie Architectural Papers. Photographed at the Pennsylvania State Archives in Harrisburg.

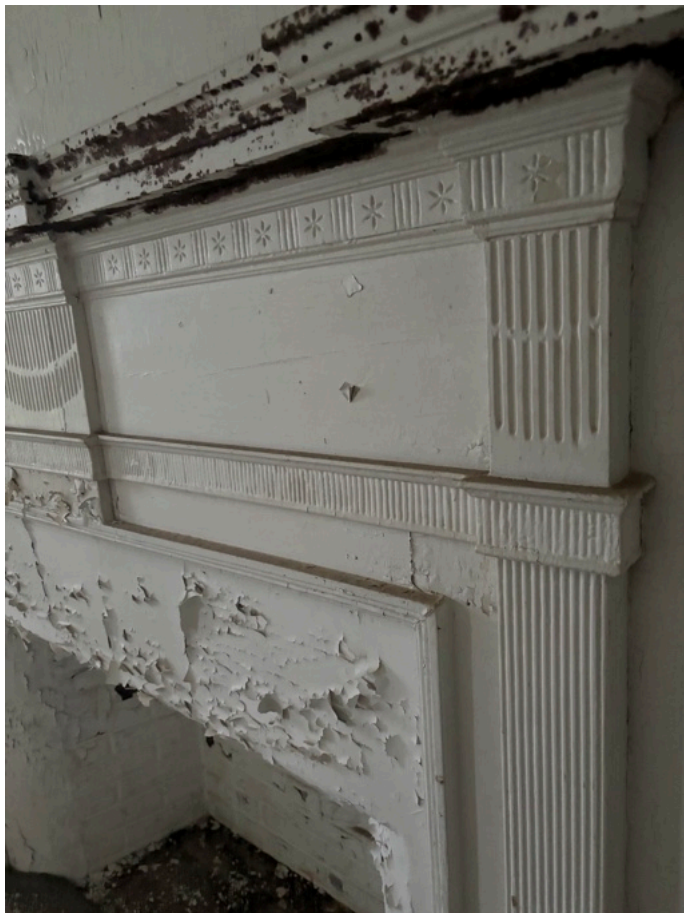
Fig. 20. Detailed woodwork on the living room mantelpiece. From the archives of the King of Prussia Historical Society.

Okie’s design of the interior of the new wing required a remodeling of the interior of the existing house to match, including the kind of intricate woodwork, carved mantelpieces, built-in cupboard, cabinets, drawers and shelving for which Okie was renowned. Many of the drawings in the R. Brognard Okie Architectural Papers were done to illustrate the highly detailed woodwork (figs 19 & 20.)

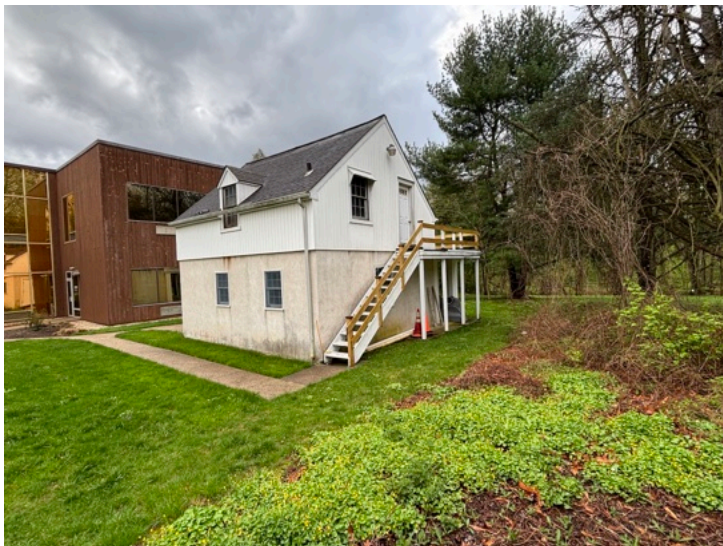
Fig. 25. The bath house, which is currently used as a maintenance facility for the office park surrounding Moore-Irwin. Current photo.

In addition to the changes to the house, the bath house was reconstructed into its current form (figs. 24 & 25.)

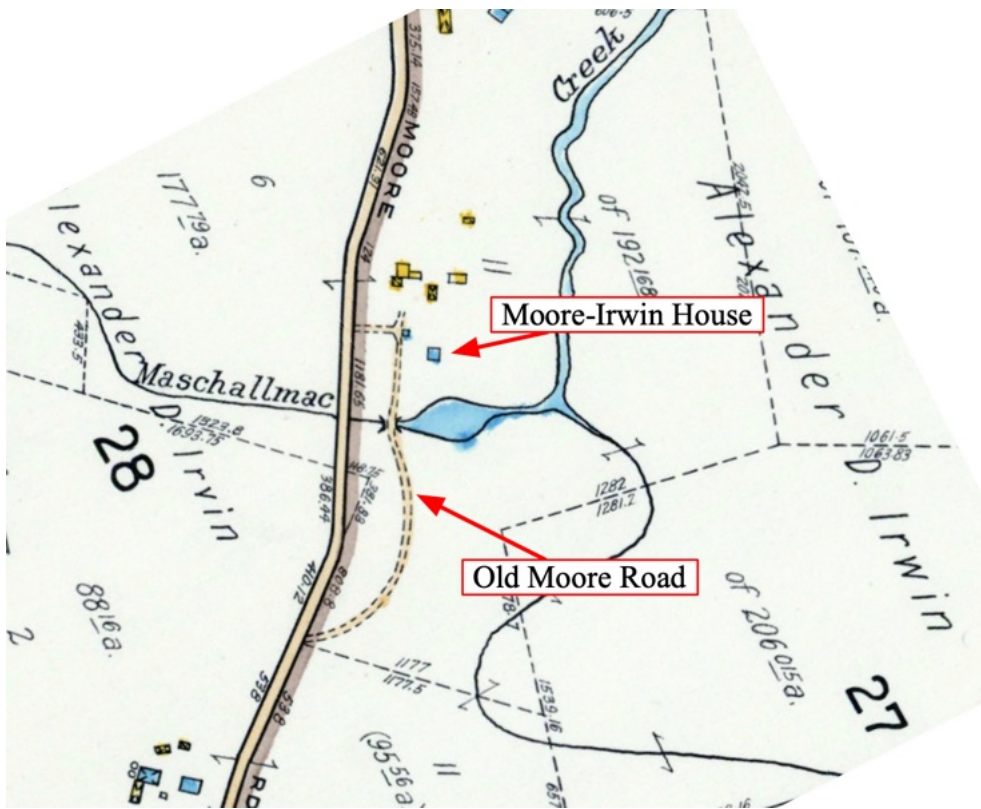
Fig. 32. Irwin's property, showing the old route of Moore Road in dotted outline. Plate 29 of the 1955 Franklin Property Atlas of Upper Merion. From the King of Prussia Historical Society Archives.

In 1935-1936, Irwin attempted to have Moore Road closed because it was being used as a “lover’s lane” and the sound of car engines running at all hours disturbed the family. The Valley Forge Park Commission and local residents successfully fought the move, leading Irwin to pay to have the road moved west, further away from the house (figs. 31 & 32.)

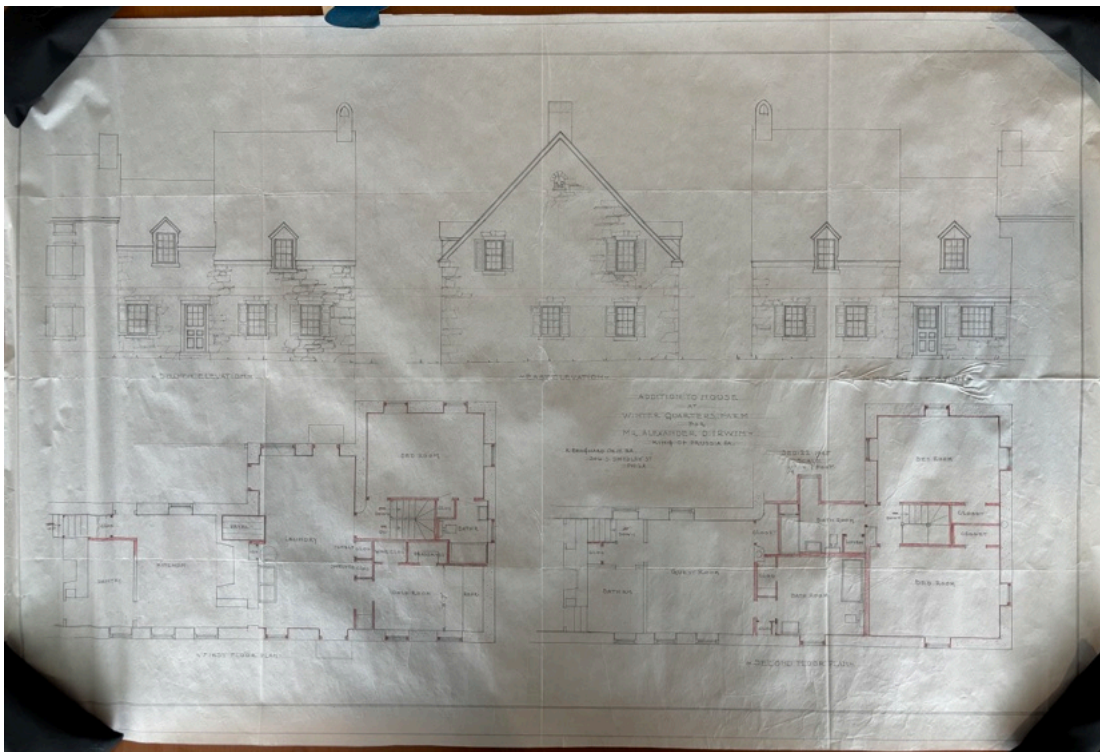
Fig. 33. Plans showing the enlargement of the servants quarters on the east side of the house, dated Sept. 22, 1945. From the R. Brognard Okie Architectural Papers. Photographed at the Pennsylvania State Archives in Harrisburg.

In 1946, the servants quarters were again enlarged. Although Okie died on December 27, 1945, the plans for the work were among the R. Brognard Architectural Papers at the Pennsylvania State Archives. The last version of the plans in the collection were drawn by Okie September 22, 1945, only three months before his death (fig. 33.) We surmise that the work was completed by Okie's son Charles.

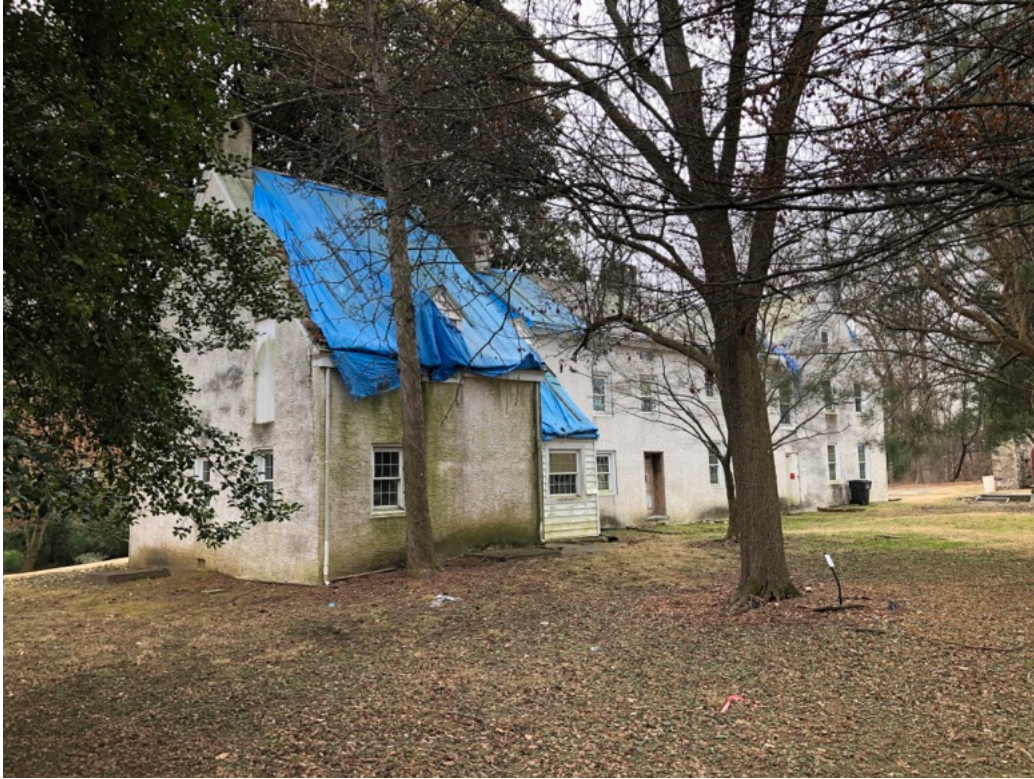
Fig. 34. The north and east side of the house, looking southwest. On the left is the 1946 east side addition to the servants quarters, with the connector just visible with siding. Current photo.

The enlarged servant's quarters enhanced the additive style that Okie was known for (figs. 34 & 35.)

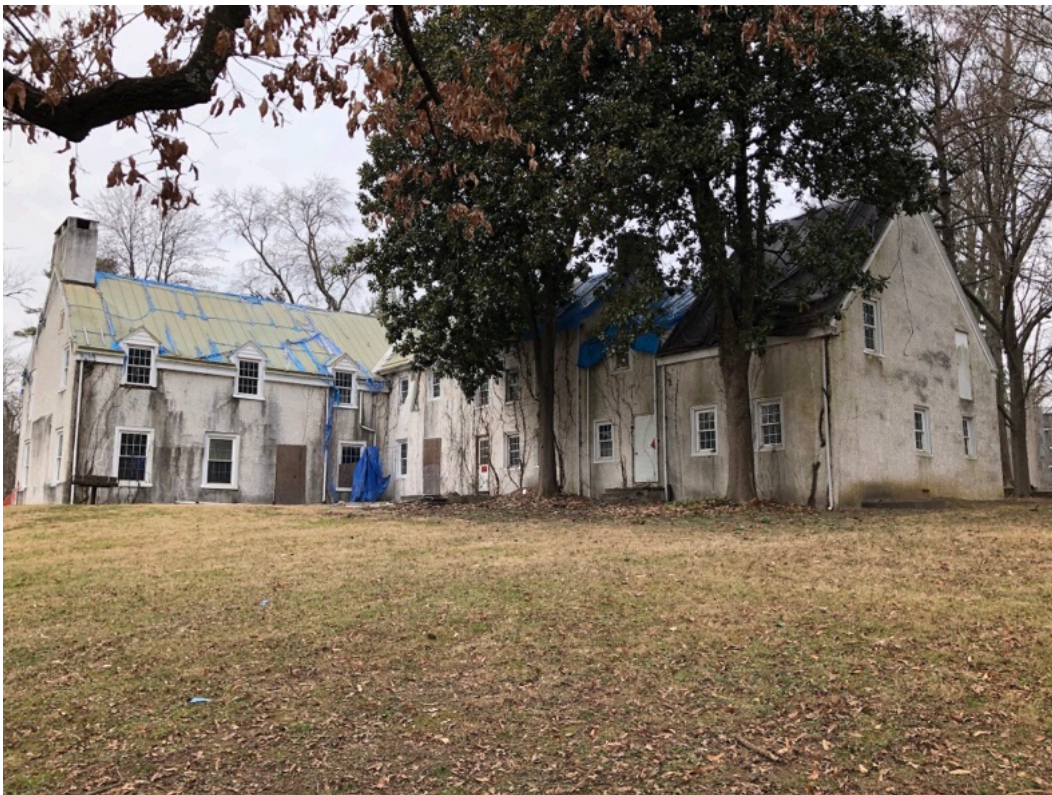
Fig. 35. The south and east side of the house, looking northwest. On the right is the 1946 east side addition to the servants quarters. Current photo.

Also visible are dormer windows that break the roofline - another common Okie design element. Most of the 1946 construction followed Okie's 1945 designs (Figs. 36-39.)

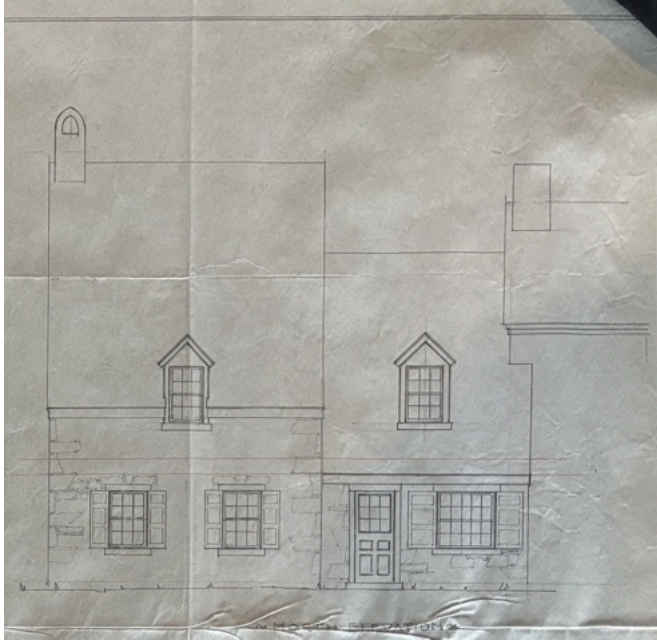
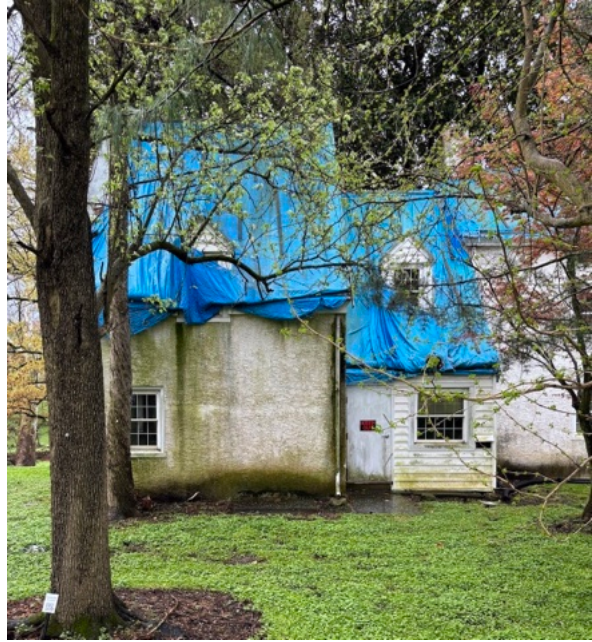
Fig. 36. Detail of fig. 35, showing the north face of the servant's quarters. From the R. Brognard Okie Architectural Papers. Photographed at the Pennsylvania State Archives in Harrisburg.

Fig. 37. The north face of the servants quarters as actually built. Current photo.

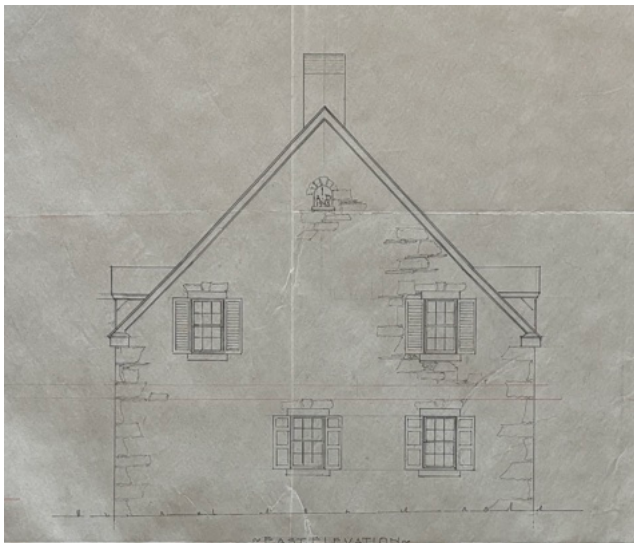
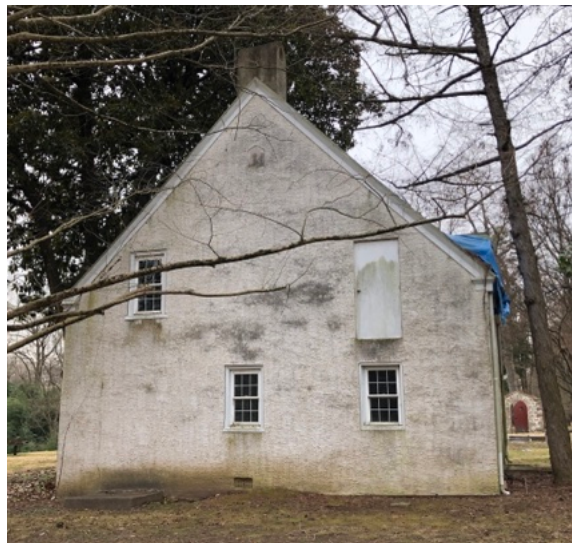
Fig. 38. Detail of fig. 35, showing the east face of the servant's quarters. From the R. Brognard Okie Architectural Papers. Photographed at the Pennsylvania State Archives in Harrisburg.

Fig. 39. The east face of the servants quarters as built, although one window was later altered by Upper Merion Township to create an emergency exit in the 1970s. The stairs that led from the door to the ground have since been removed. Current photo.

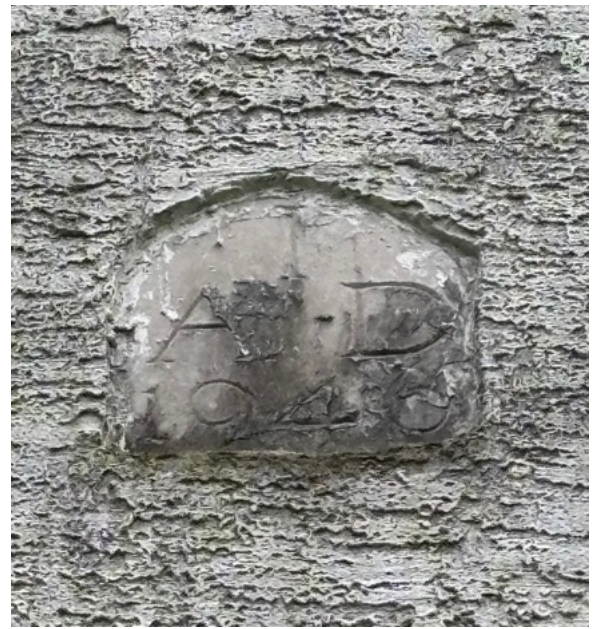
Fig. 41. The date stone as it currently appears, surrounded by rough stucco that was added much later.. Current photo.

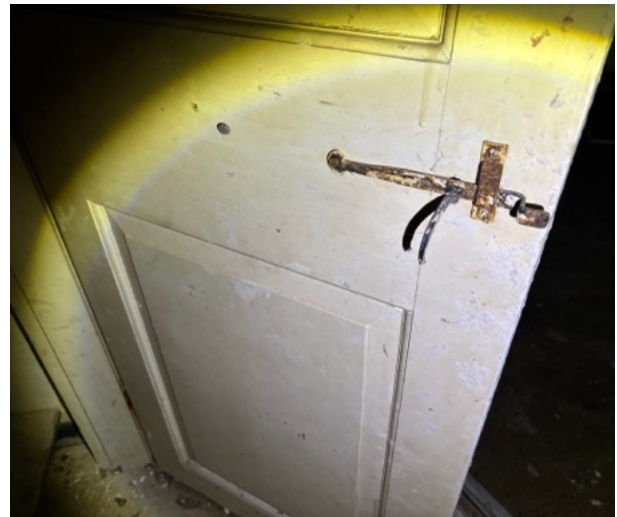
Fig. 43. Antique door latch in the servants quarters upstairs. From the archives of the King of Prussia Historical Society..

Given that these are servant's quarters, there are no extensive built-in cabinetry, cupboards or drawers, however other elements typical of Okie's work are present such as antique hardware and rounded corners (figs. 42-44.)

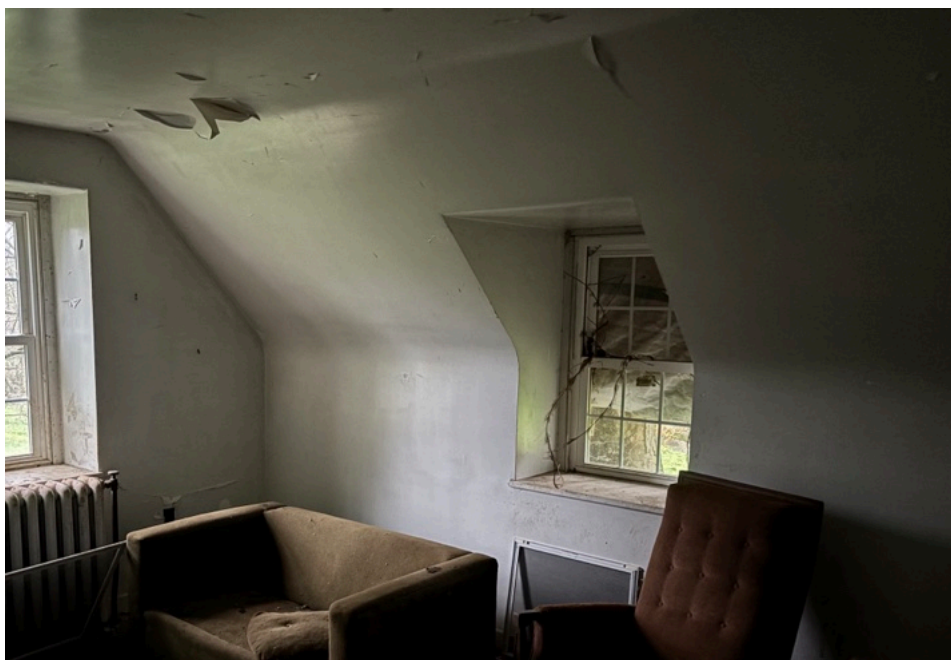
Fig. 44. Rounded ceiling in the servants quarters upstairs. From the archives of the King of Prussia Historical Society..

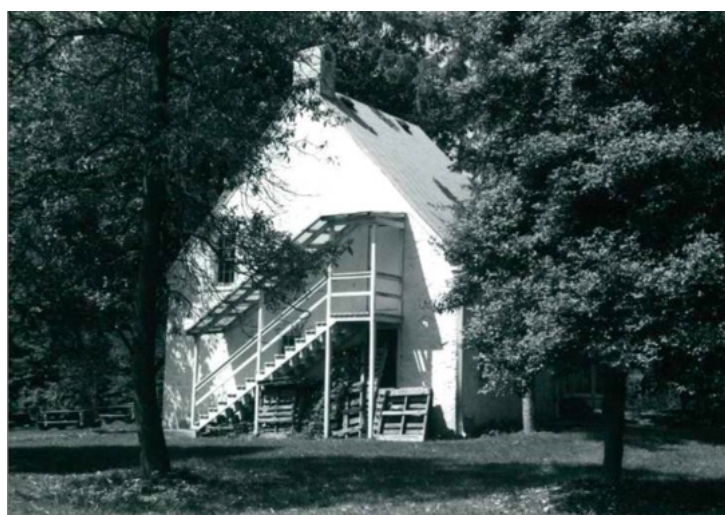
Fig. 45. The east side of the house, showing the emergency exit and stairs (since removed) from the servants quarters second floor. Photo by Dave Broida in 1979.

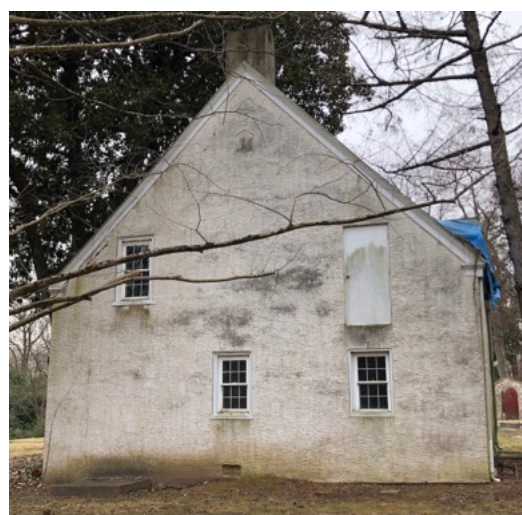
Fig. 46. The east side of the house, showing the emergency exit from the servants quarters second floor. Current photo.

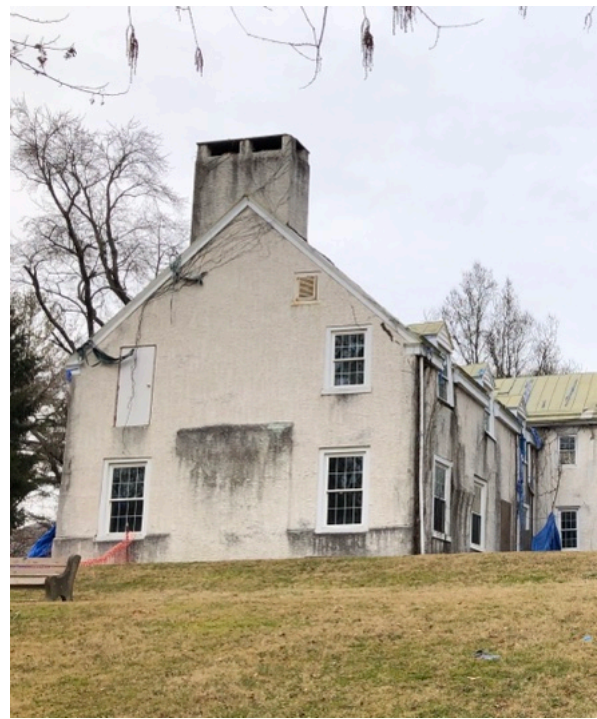
Fig. 48. The south side of the 1932 Okie addition, showing the emergency exit from the second floor. Current photo.

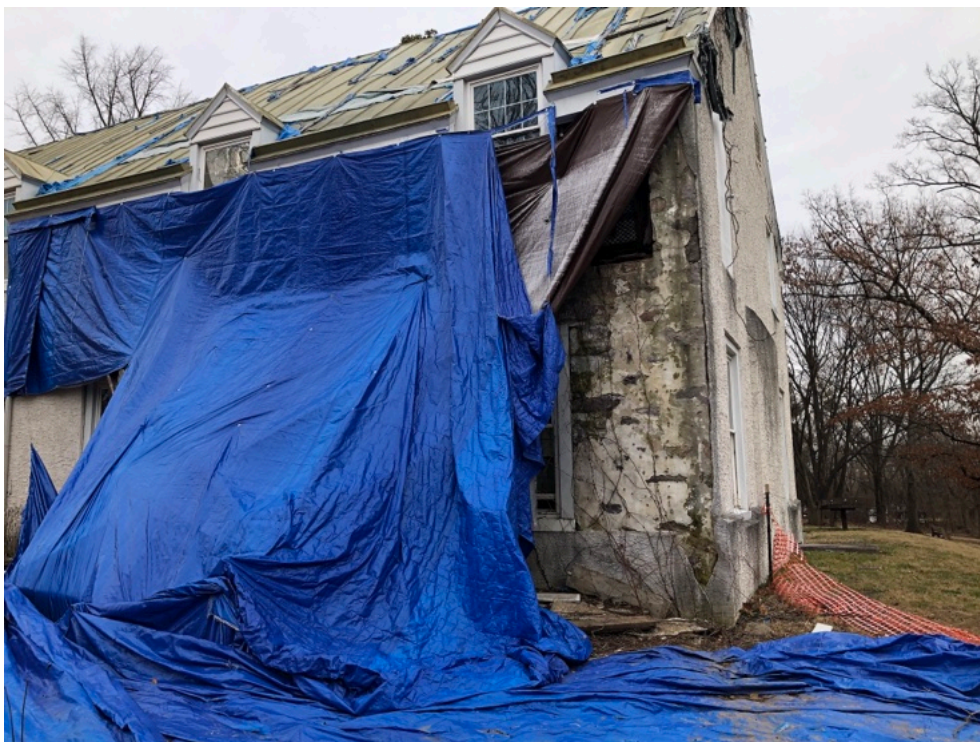
Fig. 49. The southwest corner of the 1932 Okie addition showing the falling away of the stucco on mesh, revealing the intact original stucco on stone.

From the time the house was sold in 1957 to now, the house has been allowed to fall into disrepair. By 1992, Upper Merion Parks & Recreation moved out of the house due to deterioration. But given the long period of neglect, the house is in remarkably stable condition. Murray Associates Architects and Whitney Bailey Cox & Magnani Structural Engineers submitted a facility condition and stabilization assessment in 2021 (included as a separate attachment.) Their main recommendations for immediate structural repairs are roof and roof frame replacement, and delamination of the stucco on mesh.
