Okie's Mark on Moore-Irwin

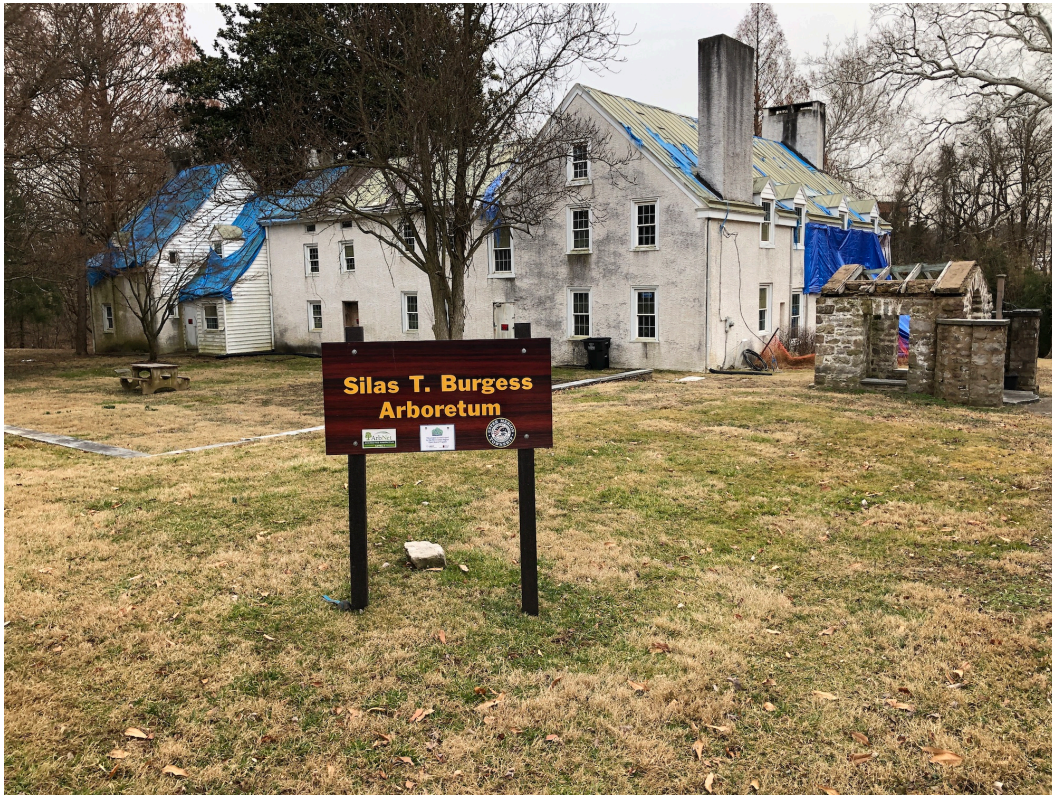
Fig. 2. The north and west side of the house, looking southeast. On the right is the 1932 addition with dormer windows that break the roofline and cross-gabled roofline. The large chimneys are also visible. The 1946 addition is on the left side with two different rooflines, also with dormer windows that break the rooflines. Current photo.

Additive Style. The segmented, yet unified appearance of the house is one of the many indications of Okie's style. The 1932 addition forms an ell-shaped extension on the west side of the house, projecting southward with cross-gabled roof. The 1946 addition creates a broken roofline on the eastern side of the house (figs. 2-4.)

Dormer windows that break the roofline. The 1932 addition is lined with seven such windows, three on the east side and four on the west side (figs. 2, 3, 5, 6, 8 & 9.) The 1946 addition has four, two on the north face and two on the south (figs. 13-15.) Unfortunately, the windows themselves have been replaced with modern windows.

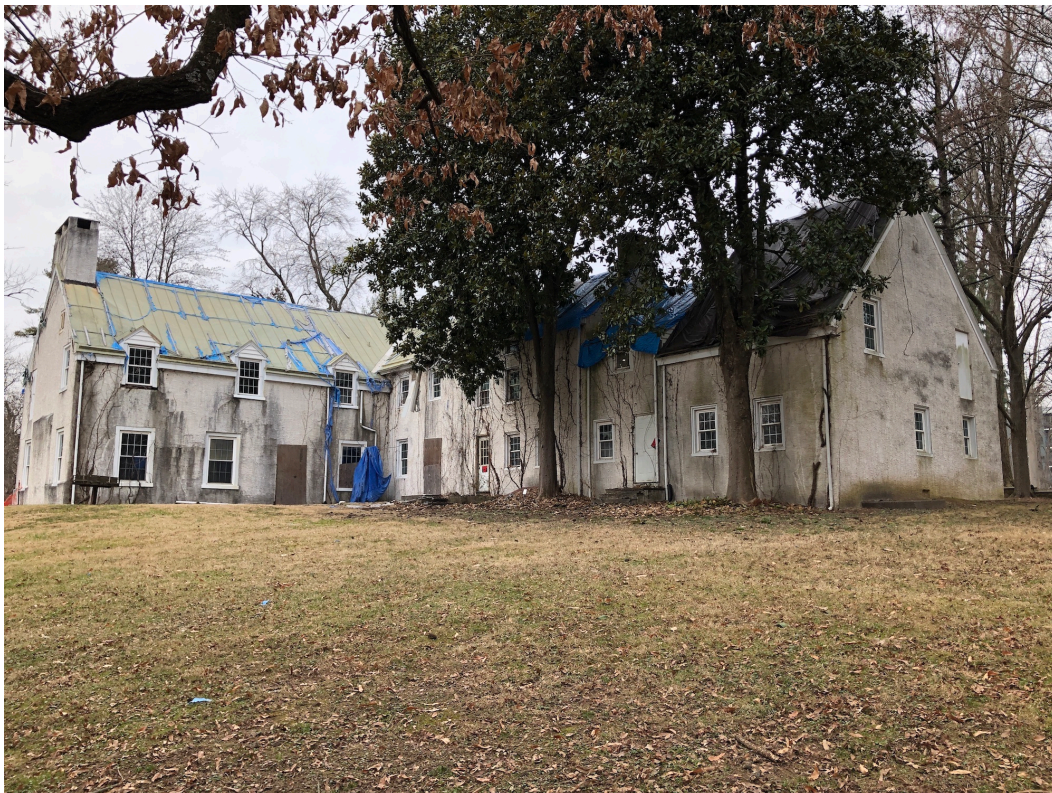
Fig. 3. The south and east side of the house, looking northwest. On the left is the 1932 addition while on the right is the 1946 addition. Current photo.

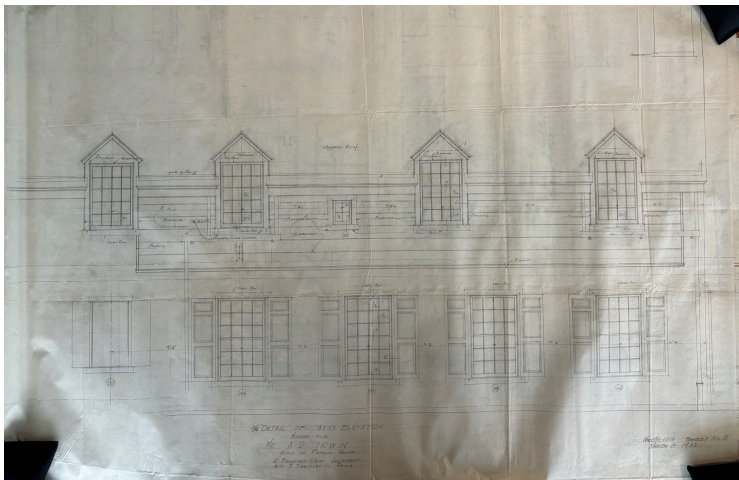
Fig. 5. West side elevation drawing of the 1932 addition showing partial clapboard siding. From the R. Brognard Okie Architectural Papers. Photographed at the Pennsylvania State Archives in Harrisburg.

Part of that additive style combines stucco on stone with clapboard on the 1932 addition (figs. 5 & 6), as well as on the 1946 addition (fig. 7.) The stucco on mesh that was added later is currently falling away revealing the original facade (fig. 8.)

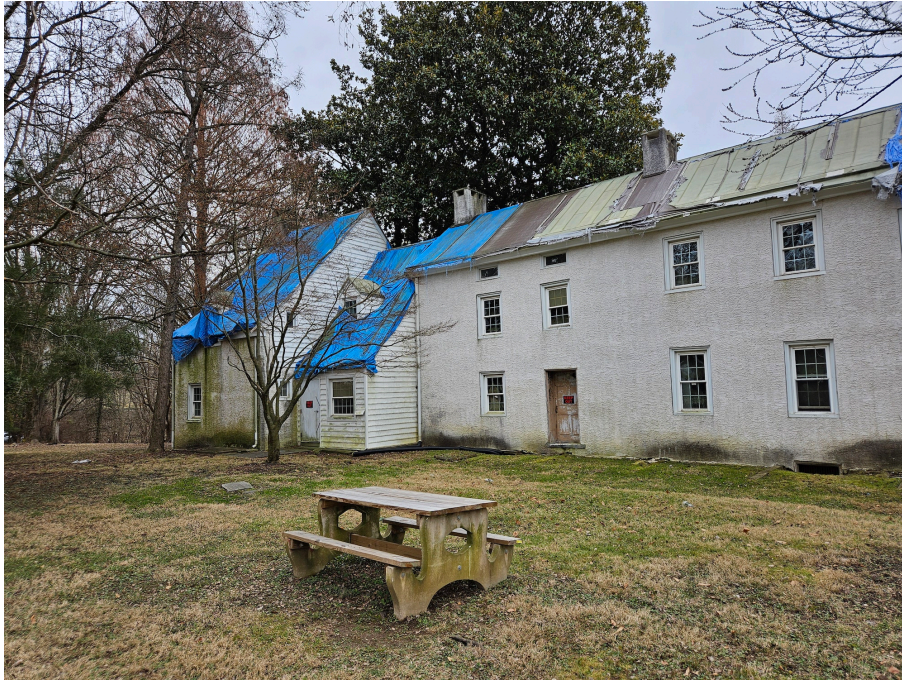
Fig. 7. Clapboard siding on part of the 1946 addition on the left in the photo. Current photo.

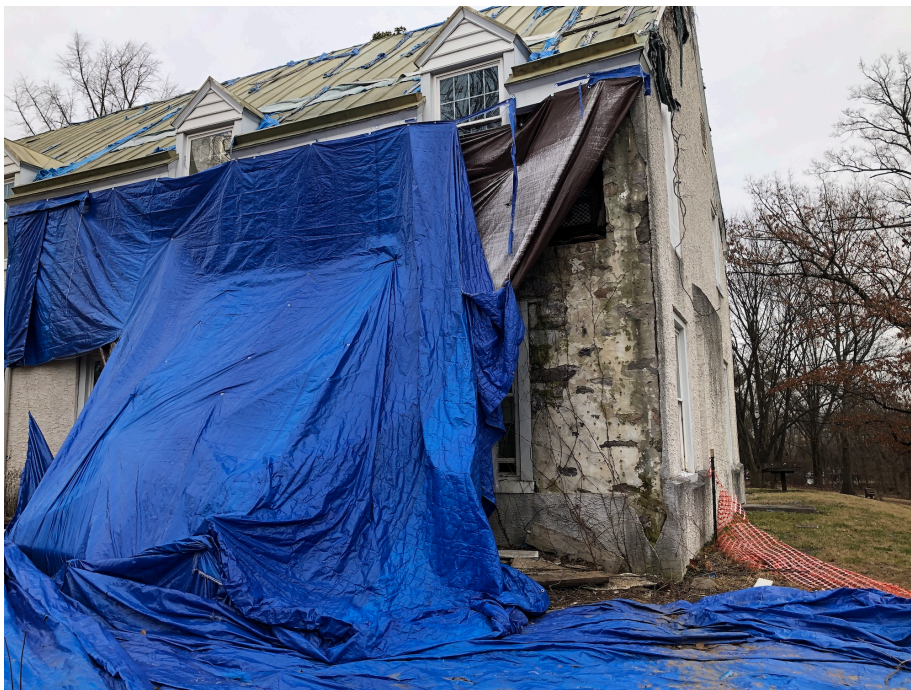
Fig. 8. The southwest corner of the 1932 Okie addition showing the falling away of the stucco on mesh, revealing the intact original stucco on stone. Current photo.

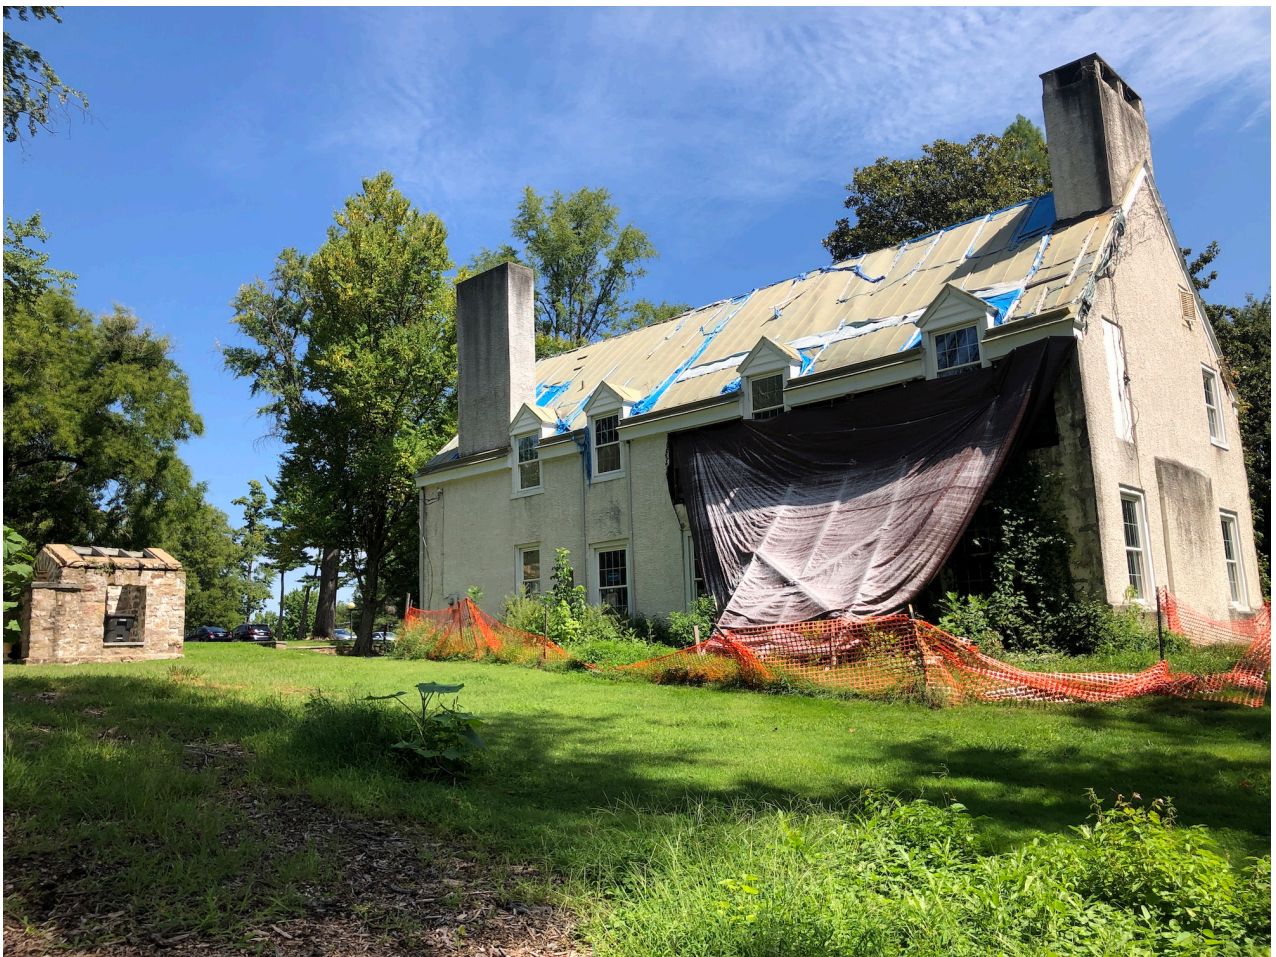
Fig. 9. Chimneys of the 1932 addition. Current photo.

Prominent chimneys. The 1932 addition has two large chimneys, one at the eastern end of the house, and the other at the southern end of the addition. The chimney in the 1946 addition is not as large, as this area of the house was servant's quarters (figs. 9 & 10.) Date stones on or near the chimneys were also a feature of Okie design, and one is visible on the 1946 addition (figs. 11 & 12.)

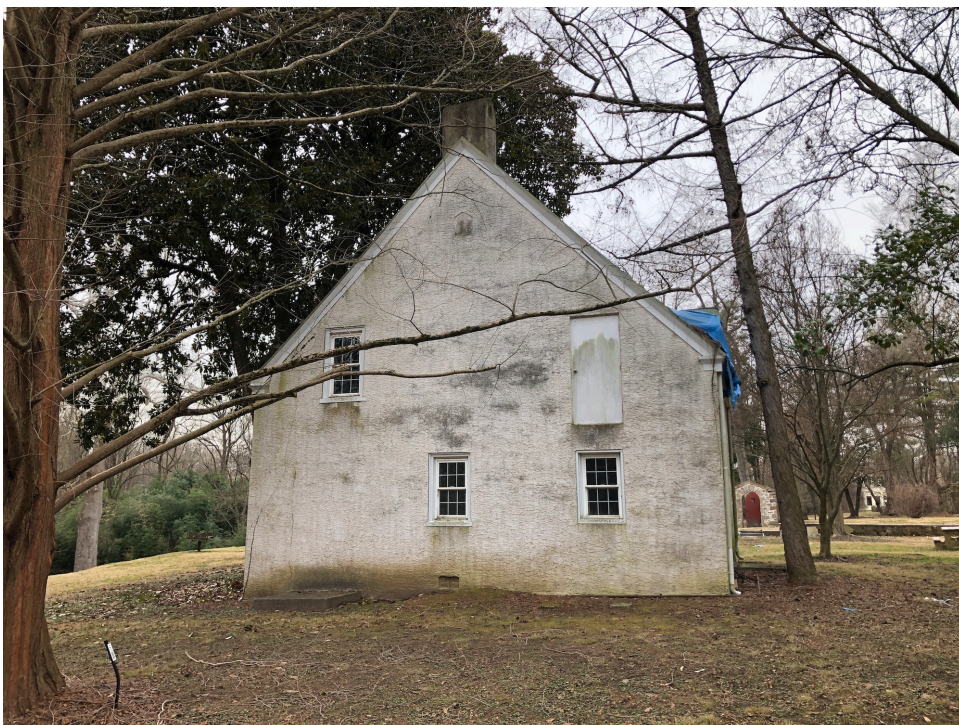
Fig. 10. Chimney of the 1946 addition. Current photo.

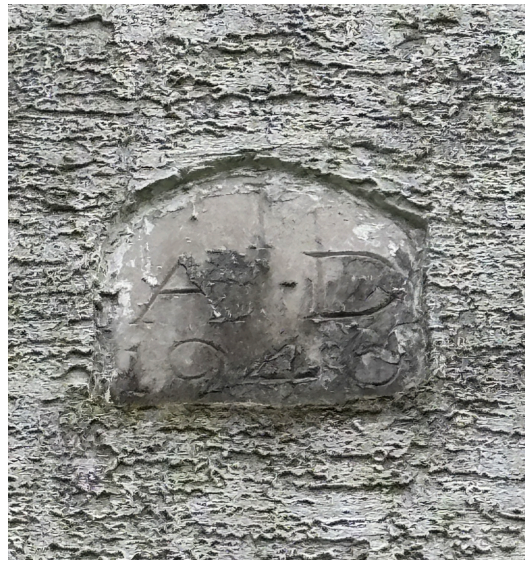
Fig. 12. The date stone as it currently appears, surrounded by stucco on mesh that was added much later and is beginning to fall away. Current photo.

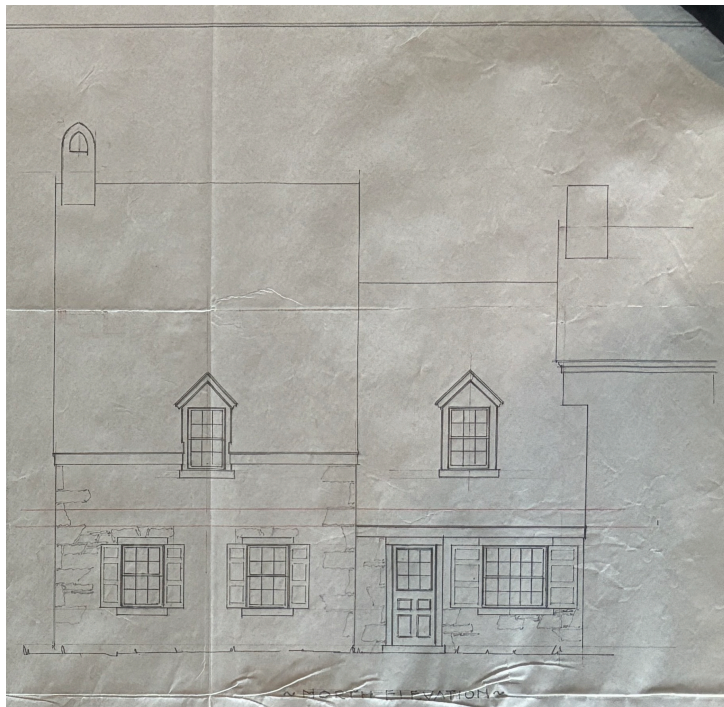
Fig. 13. Detail of plans for the 1946 addition, showing the north face of the servant's quarters. From the R. Brognard Okie Architectural Papers. Photographed at the Pennsylvania State Archives in Harrisburg.

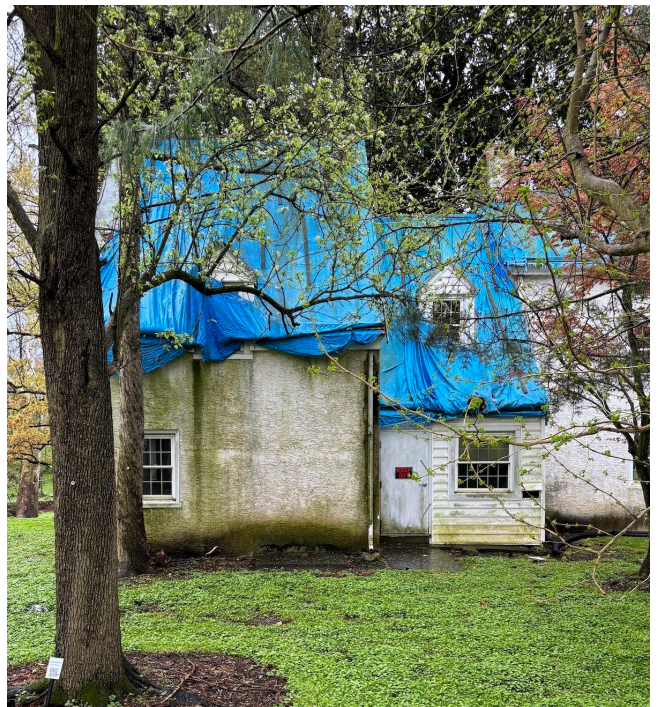
Fig. 14. The north face of the servants quarters as actually built with later stucco on mesh added and door changed. Current photo.

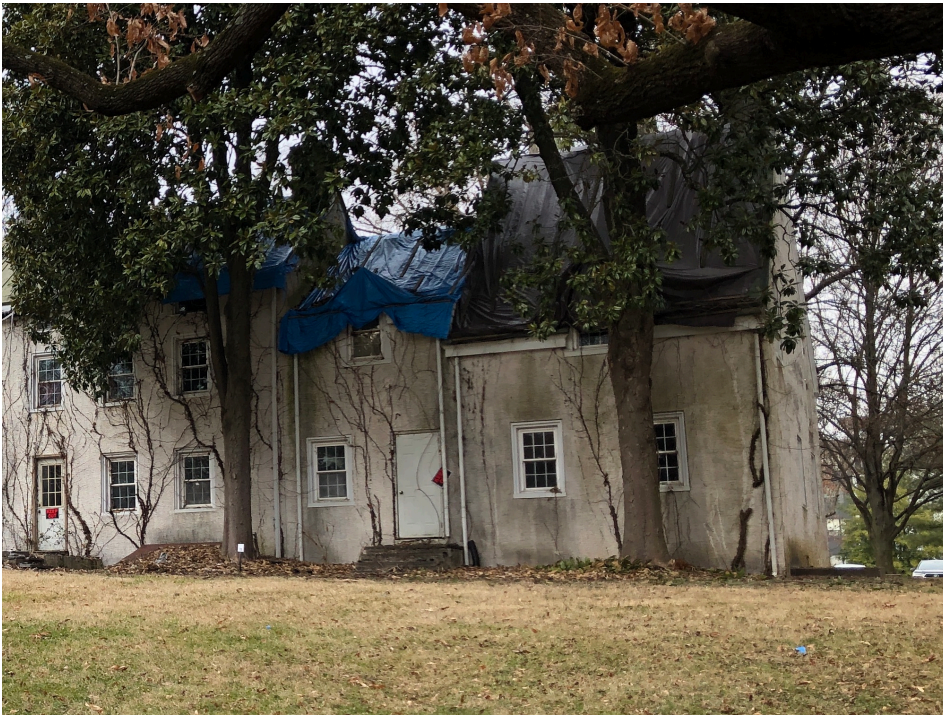
Fig. 15. The south face of the 1946 addition. The dormer windows are just visible under the tarps. Current photo.

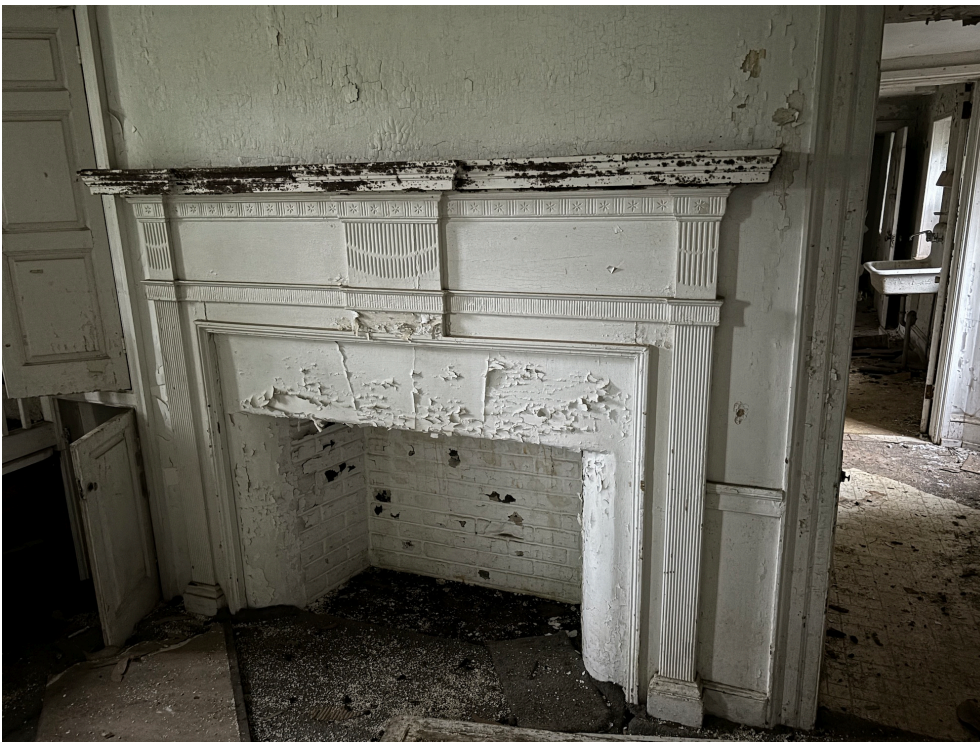
Fig. 16. Fireplace at the east end of the c. 1820 portion of the house. Current photo.

Large fireplaces with highly carved surrounds. The fireplaces in the 1932 addition are quite large and have highly detailed carved surrounds. The fireplaces in the circa 1820 portion of the house also received the same treatment (figs. 16-23.)

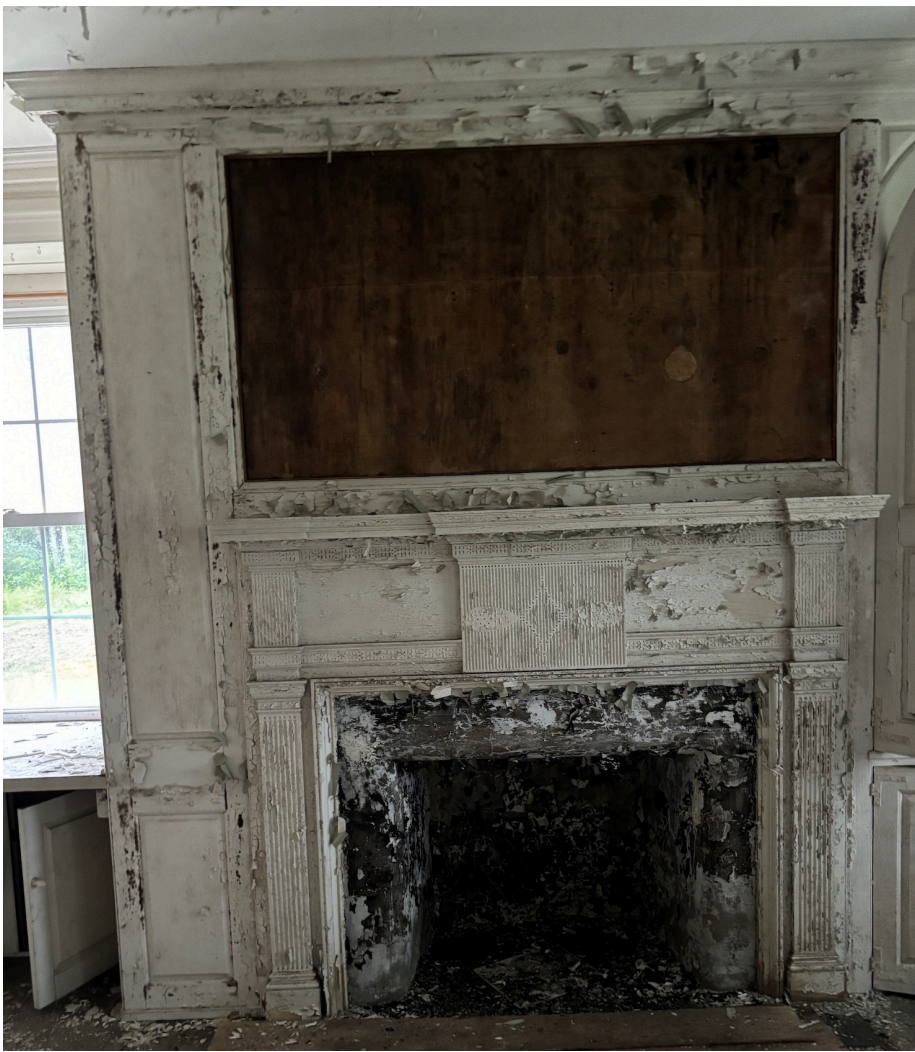
Fig. 16. Fireplace at the west end of the c. 1820 portion of the house with the carving shown in the plans below. Current photo.

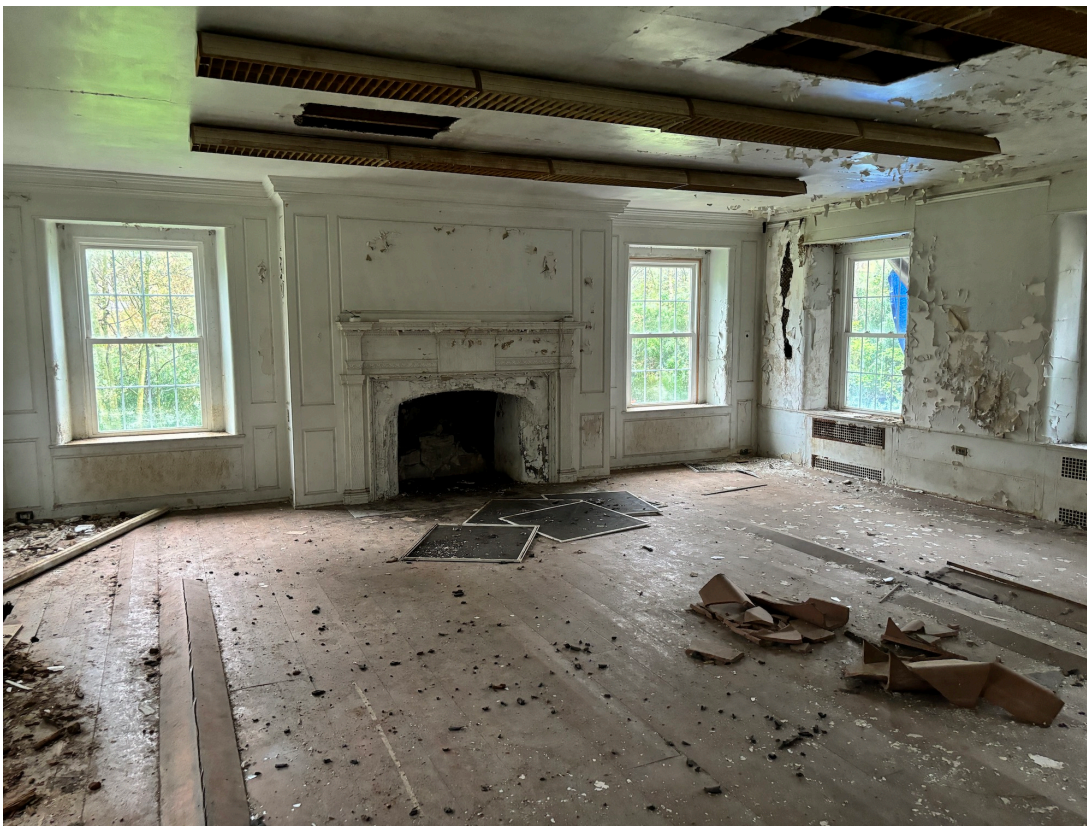
Fig. 19. Large fireplace and windows downstairs in the 1932 addition Current photo.

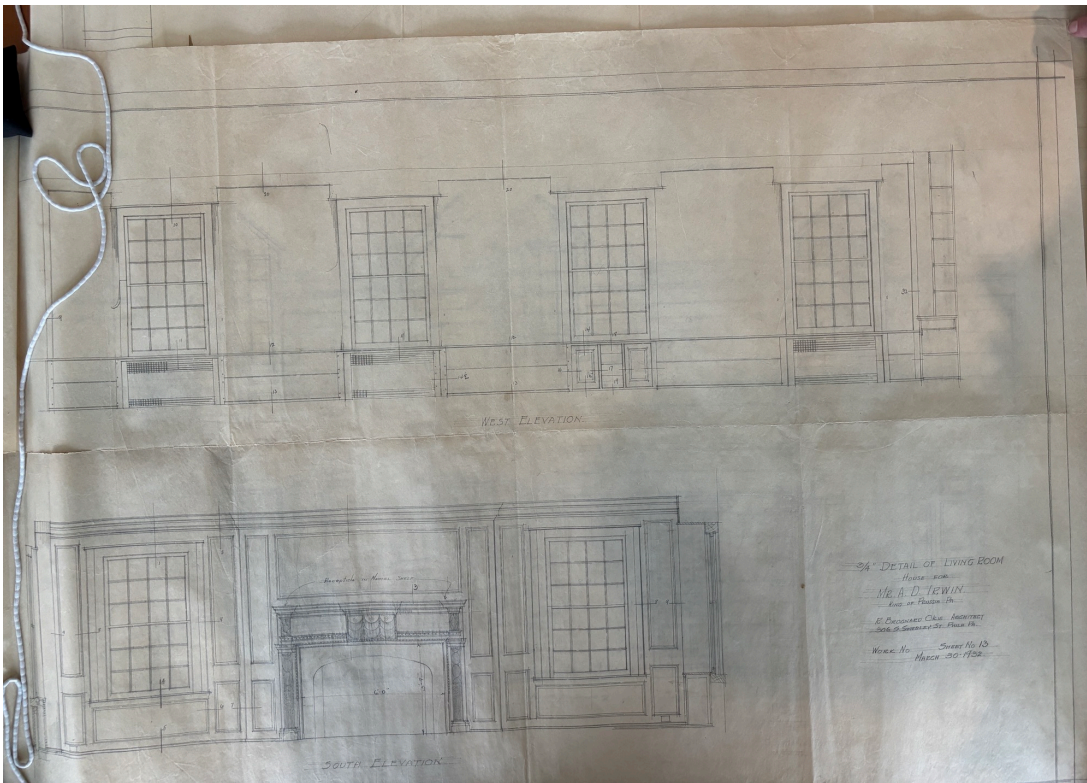
Fig. 20. Plans for the large fireplace and windows downstairs in the 1932 addition From the R. Brognard Okie Architectural Papers. Photographed at the Pennsylvania State Archives in Harrisburg.

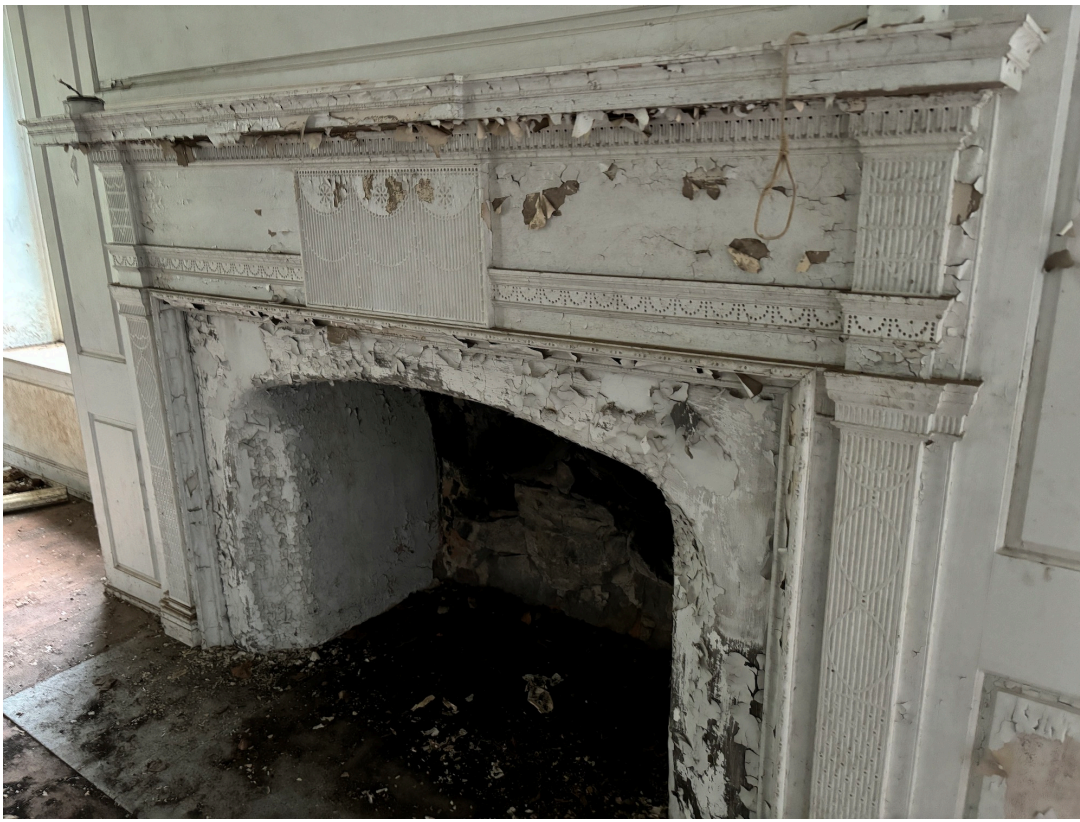
Fig. 21. Closer detail of the large fireplace downstairs in the 1932 addition Current photo.

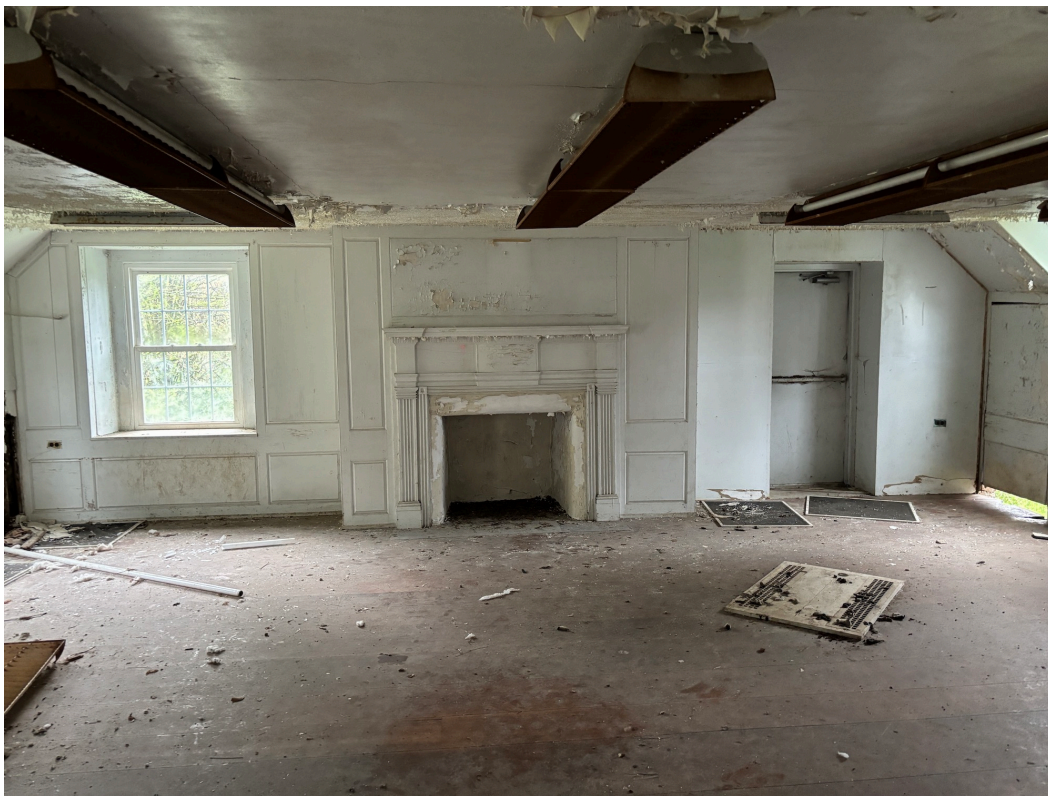
Fig. 23. Large fireplace upstairs in the 1932 addition Current photo.

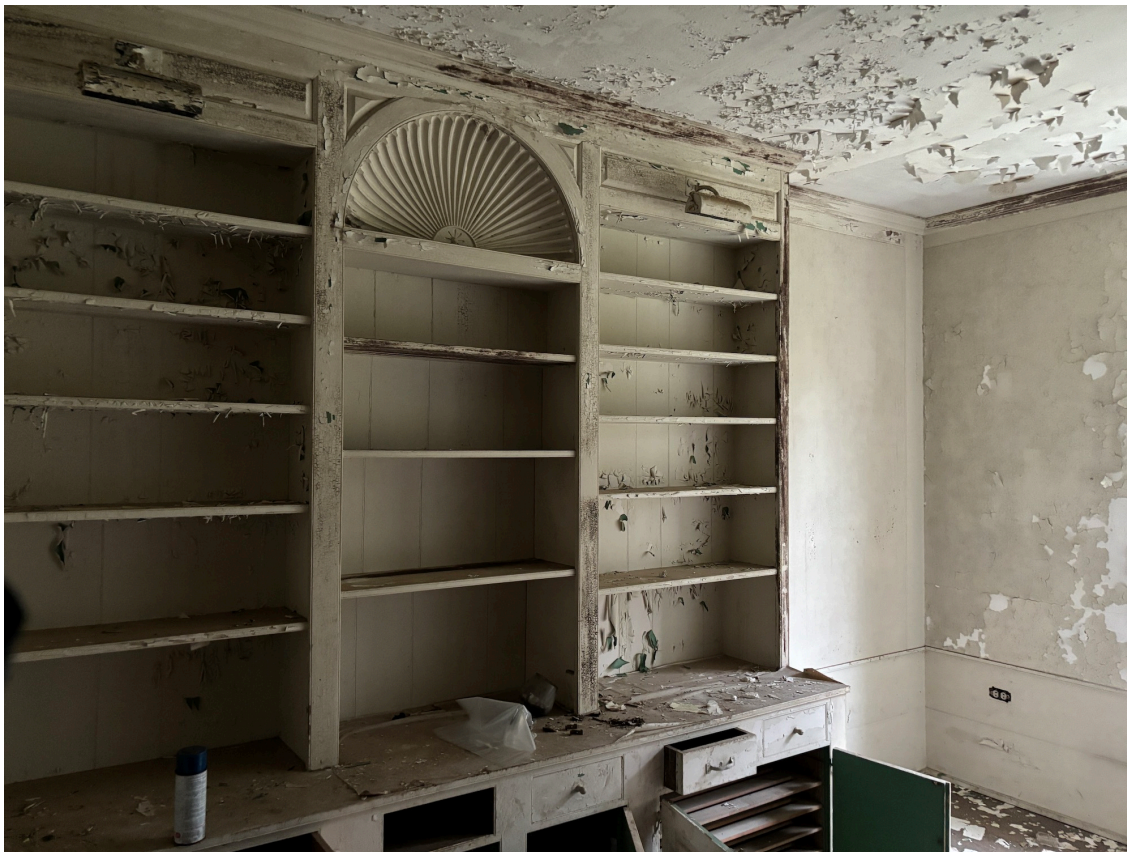
Fig. 24. Built-in shelving downstairs in the 1932 addition Current photo.

Large built-in cabinetry with decorative carving. Another hallmark of Okie's style is large shelves, cupboards and drawers built in to many of the walls of the rooms. These often have carved designs (figs. 24-30.)

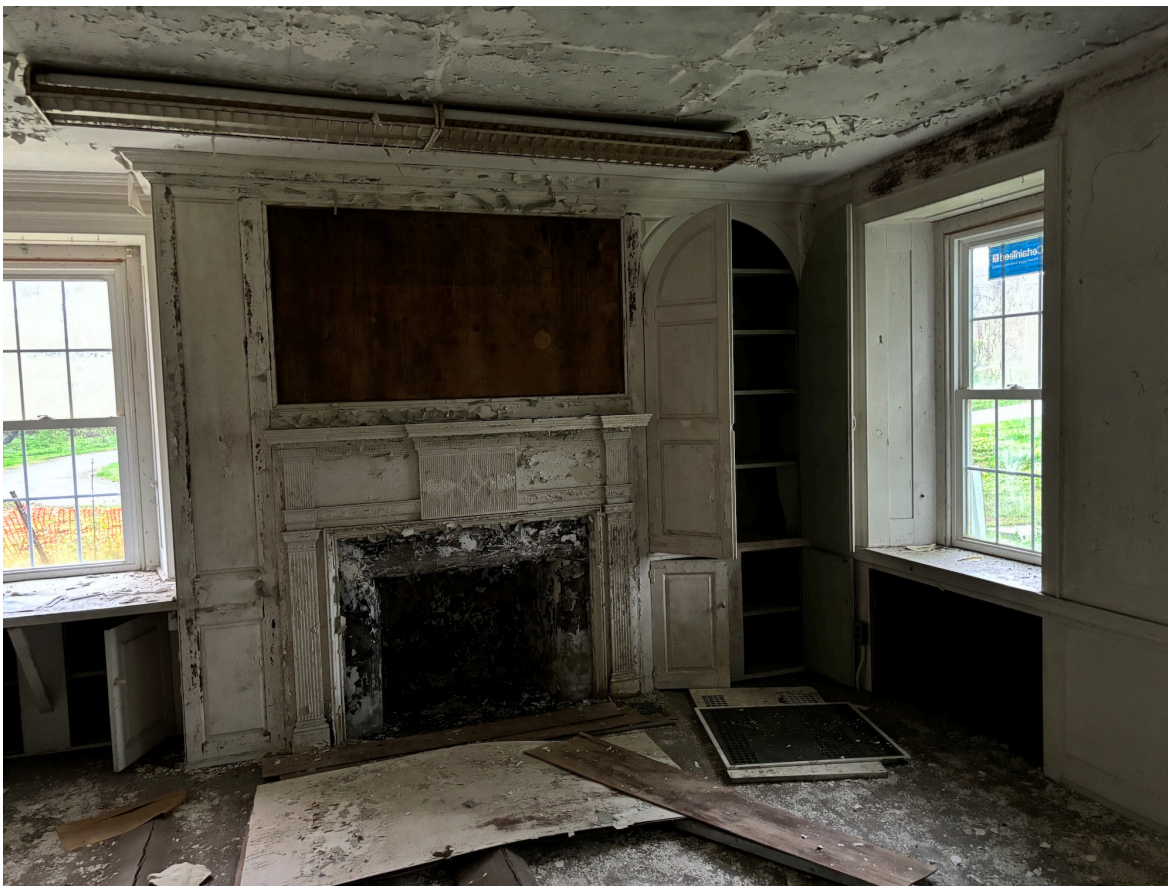
Fig. 25. Built-in cupboards next to the fireplace at the west end of the c. 1820 portion of the house. Current photo.

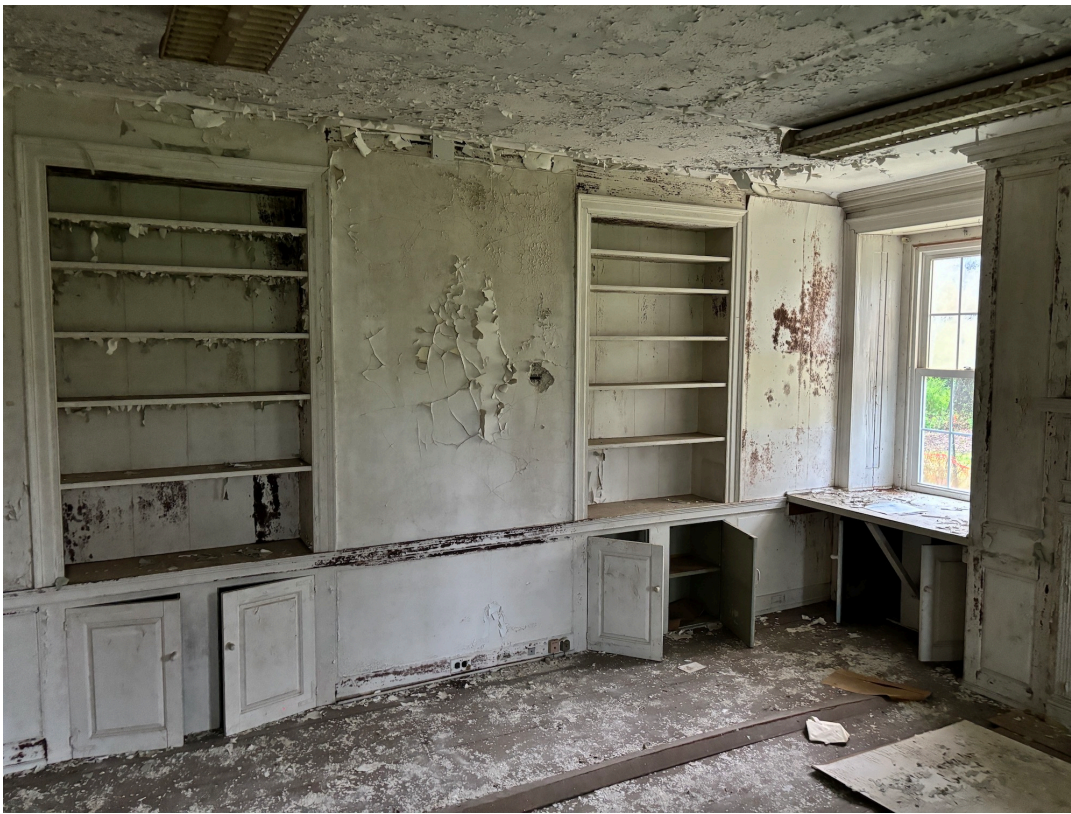
Fig. 27. Built-in shelving and cupboards downstairs in the 1932 addition. Current photo.

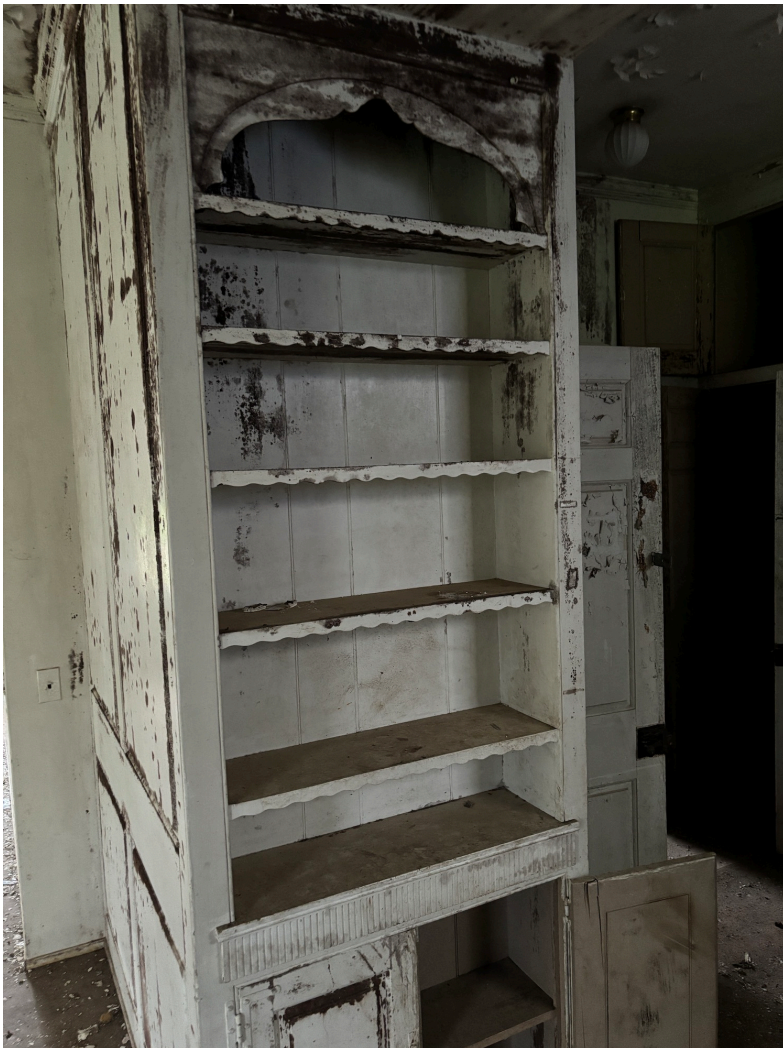
Fig. 28. Built-in shelving and cupboards downstairs in the 1932 addition. Current photo.

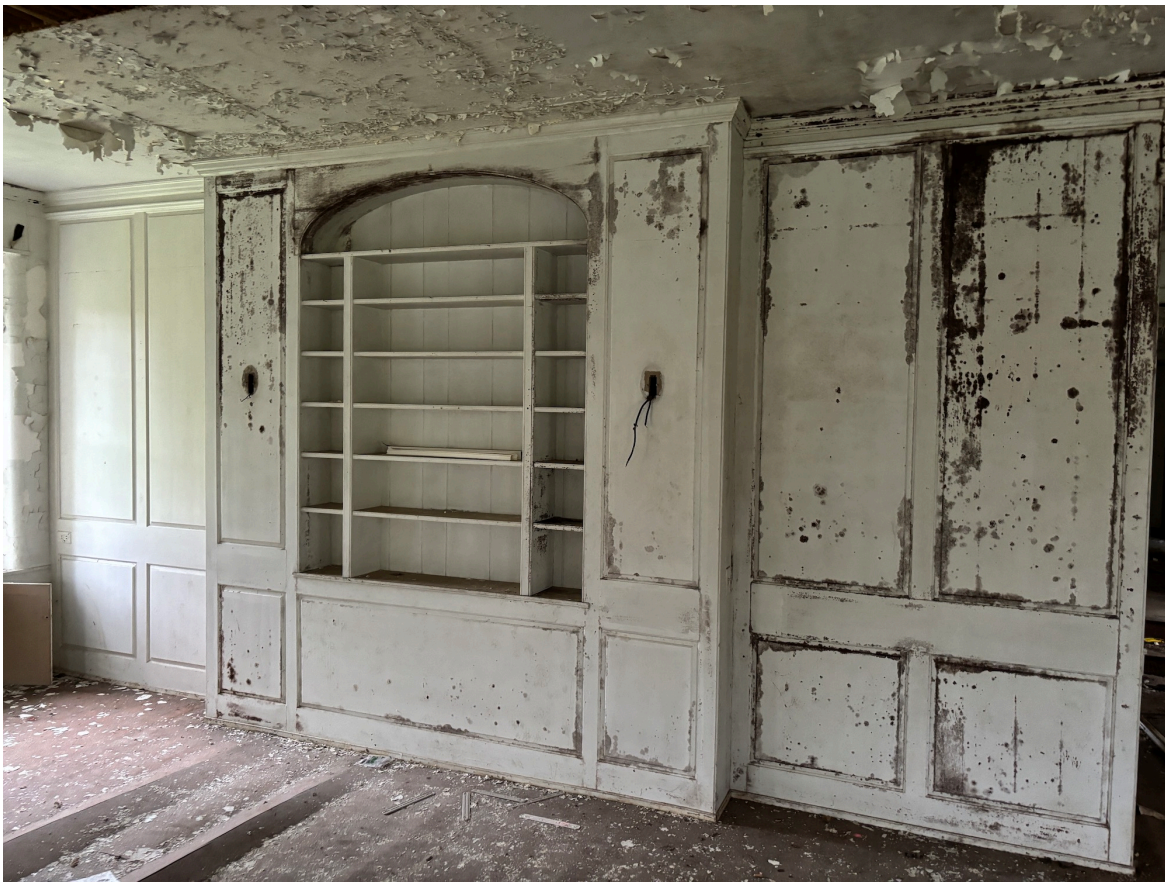
Fig. 29. Built-in shelving upstairs in the 1932 addition. Current photo.

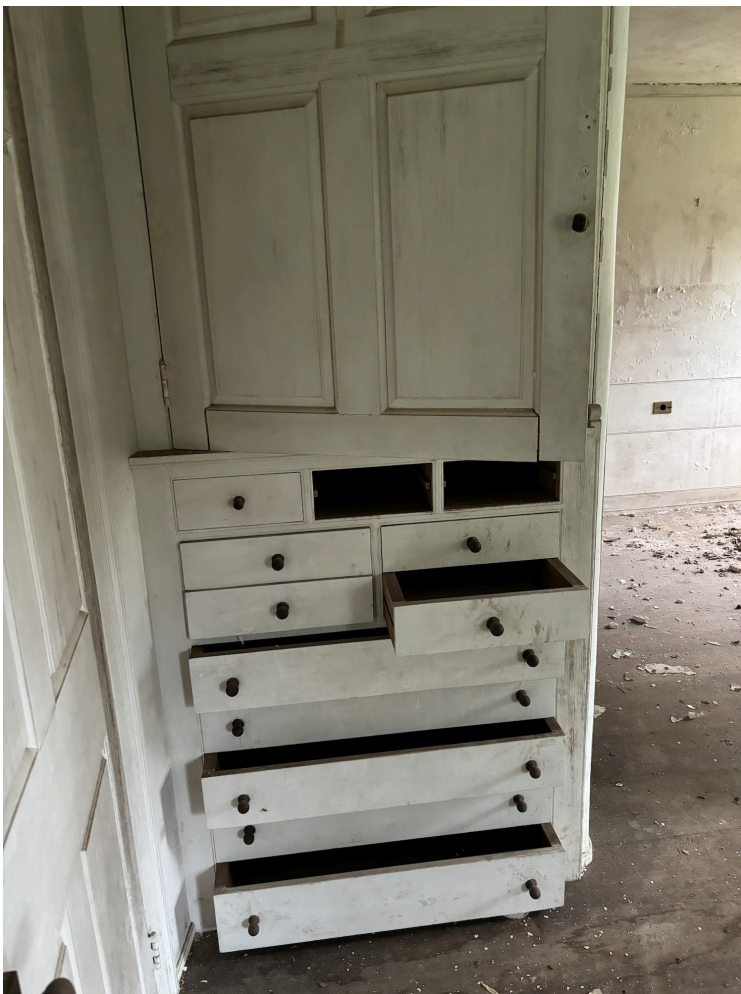
Fig. 30. Built-in cupboard and drawers upstairs in the 1932 addition. Current photo.

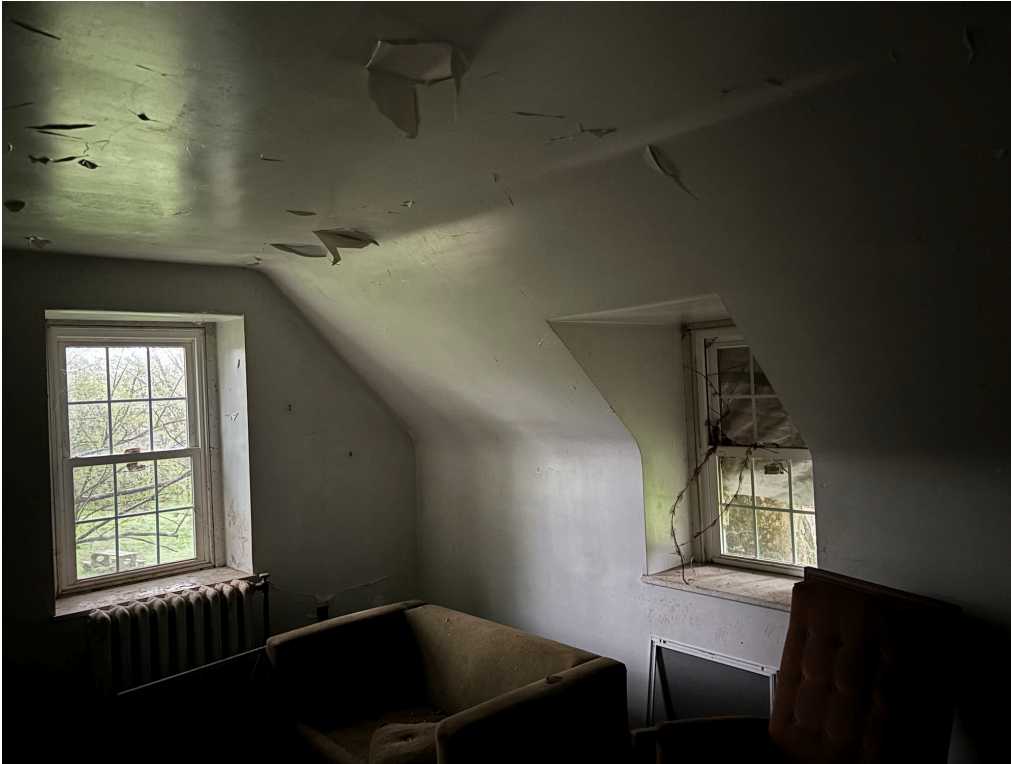
Fig. 31. Arched ceiling with curved corners upstairs in the 1946 addition. Current photo.

Rounded corners and arched passageways. There are rounded and arched corners in many parts of the house, as well as arched passageways in the 1932 addition (figs. 31-35.)

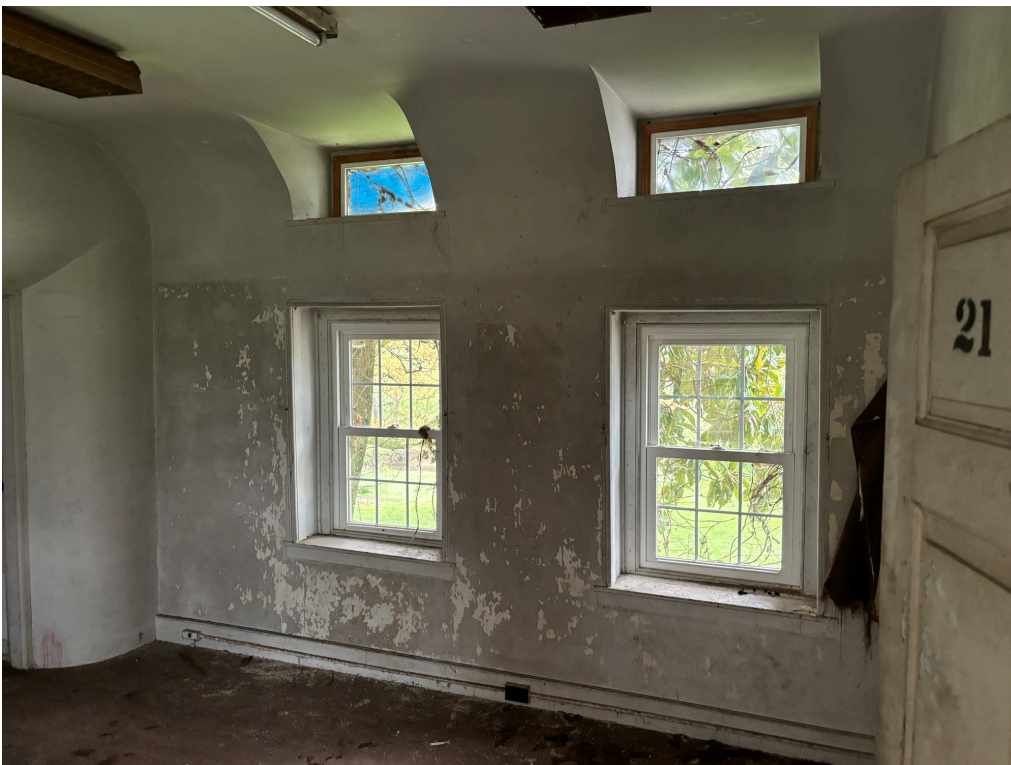
Fig. 32. Curved ceilings around the eyebrow windows upstairs in the c. 1810 portion of the house. Current photo.

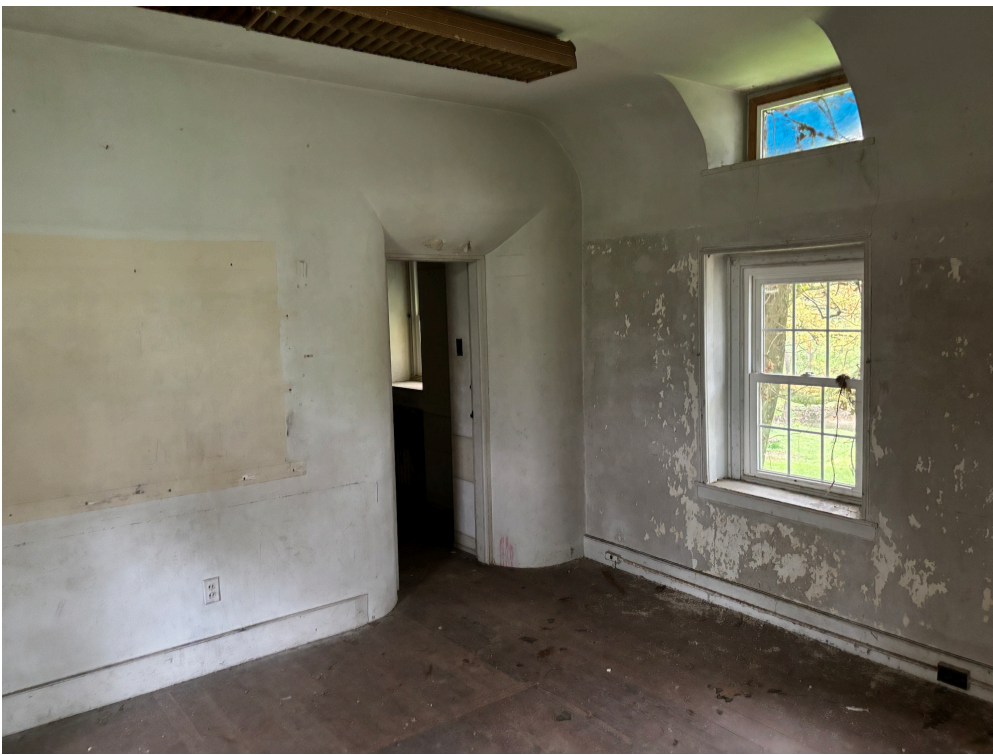
Fig. 33. Curved edges around the doorway upstairs in the c. 1810 portion of the house.. Current photo.

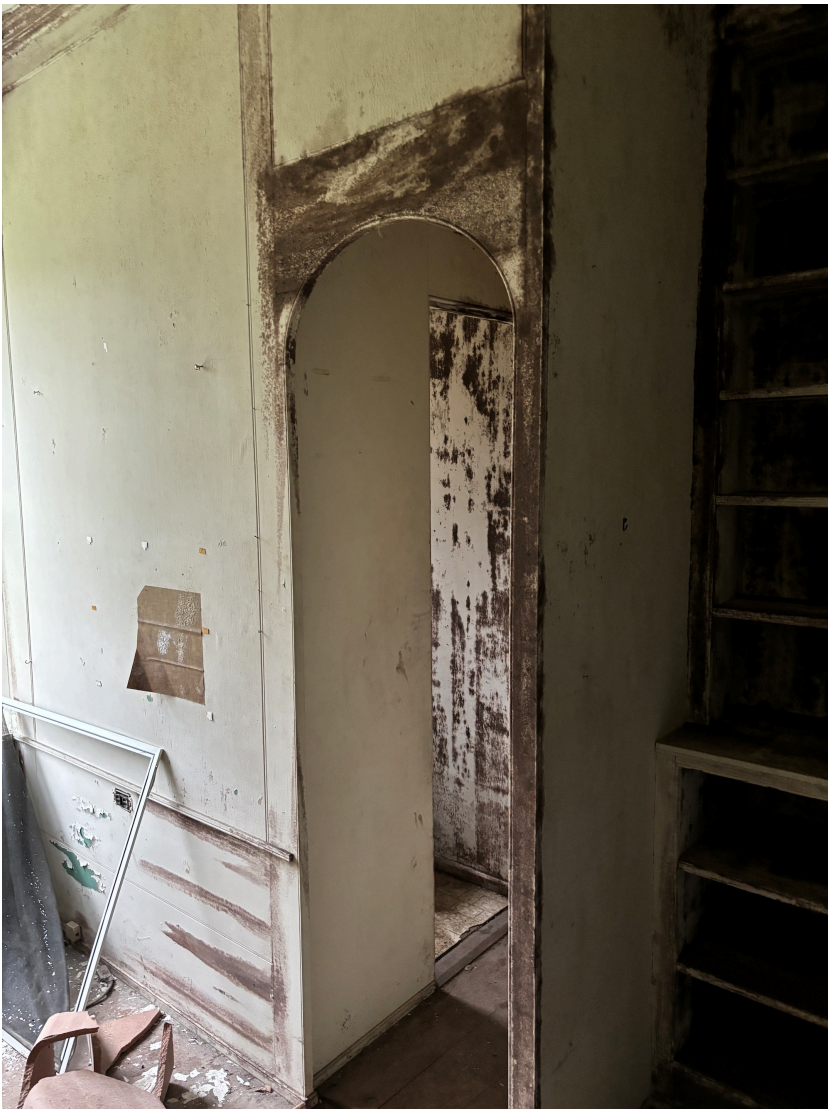
Fig. 34. Arched passageway downstairs in the 1932 addition. Current photo.
