Okie's Mark on Moore-Irwin

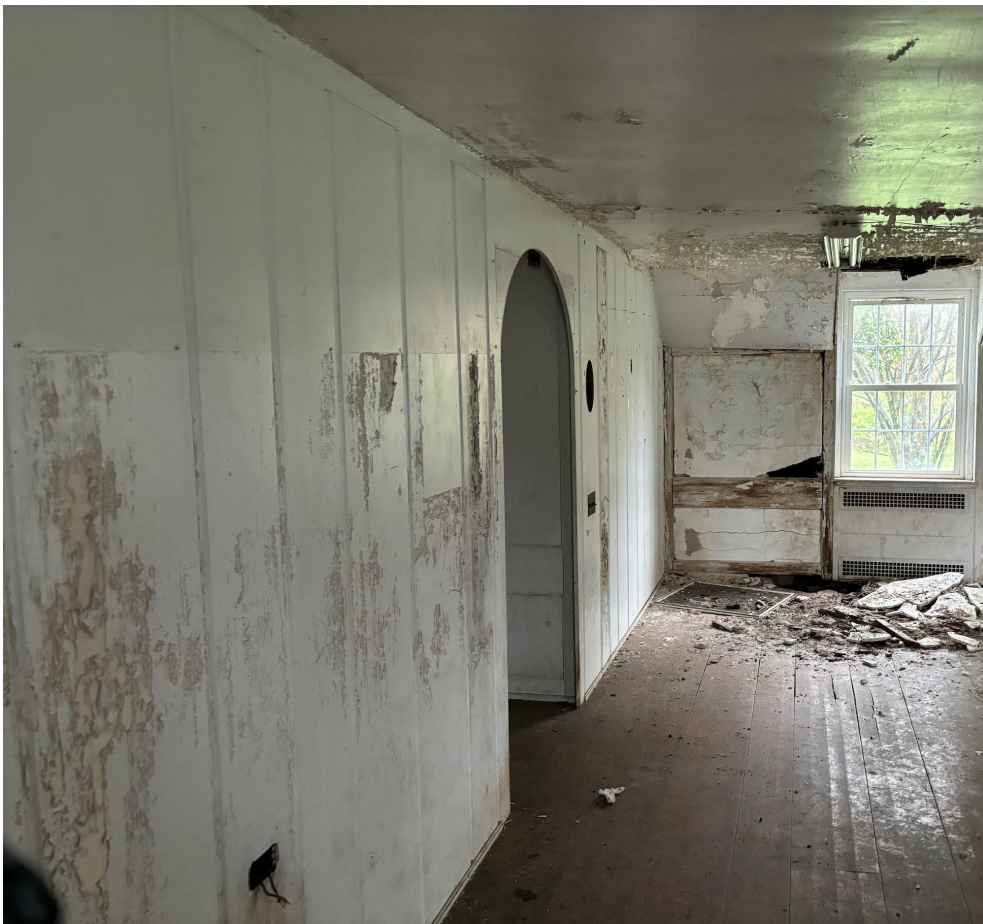
Fig. 34. Arched passageway upstairs in the 1932 addition. Current photo.

Rounded corners and arched passageways. There are rounded and arched corners in many parts of the house, as well as arched passageways in the 1932 addition (figs. 31-35.)

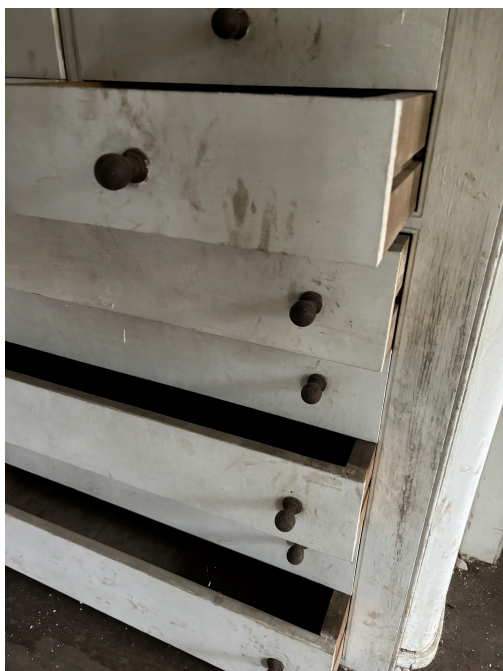
Fig. 38. The black walnut drawer pulls in the house. Current photo.

Antique style hardware. Okie's attention to detail can be seen in the very specific instructions for the hardware in the house. There are no less than six handwritten pages of notes that were sent to the hardware contractor. These include metal hinges, doorknobs, closet and cabinet door handles, latches, escutcheons and drawer pulls, many of which can still be seen throughout the house (figs. 36-44.)

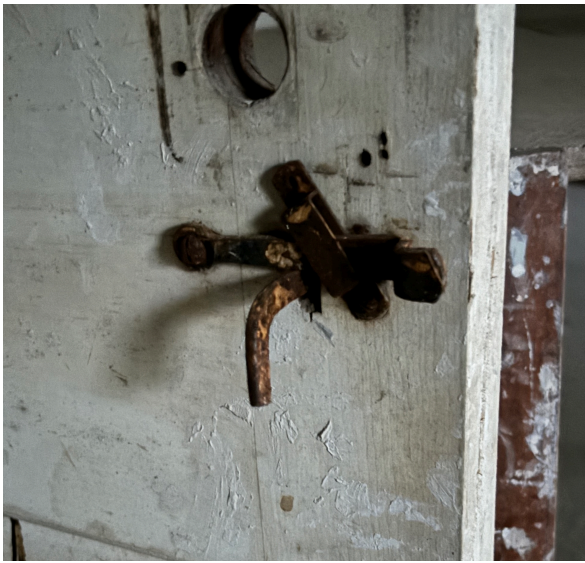
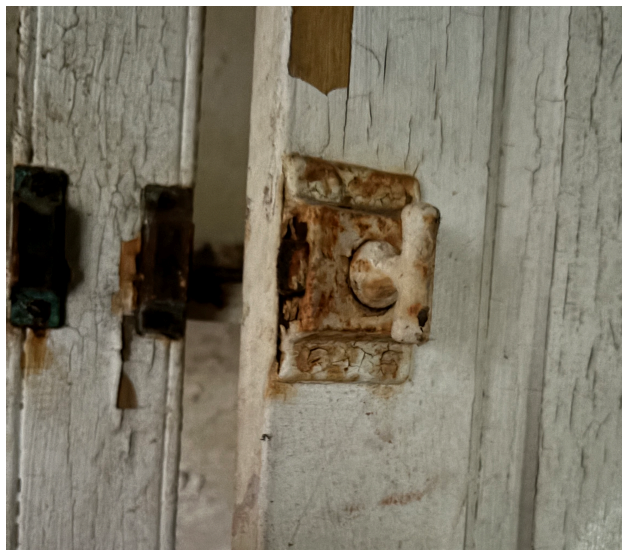
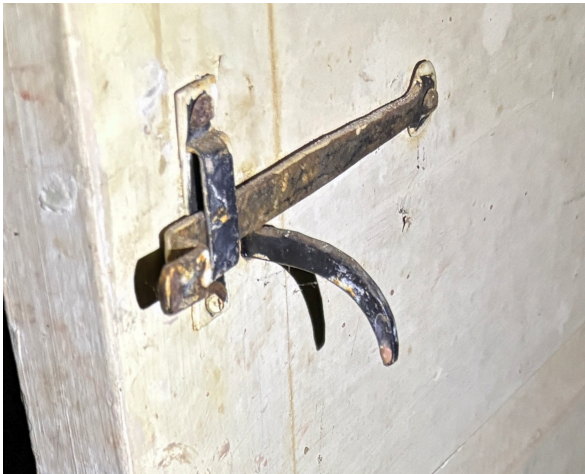
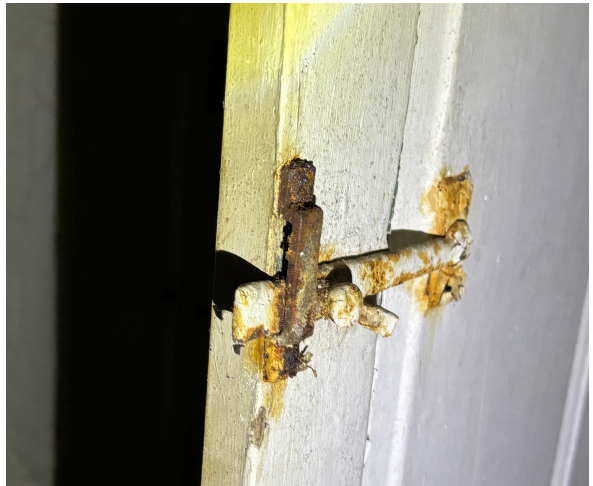
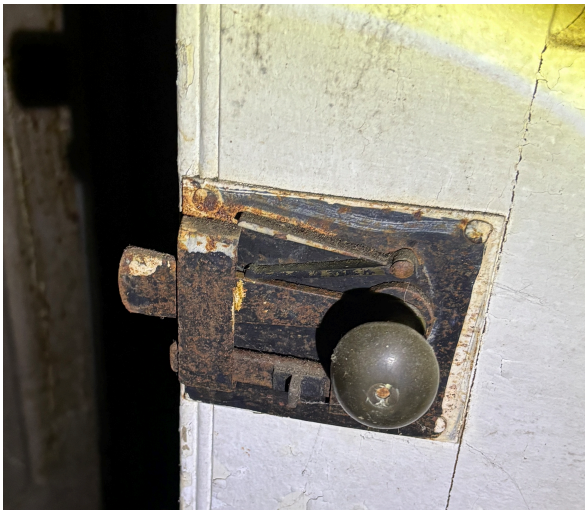
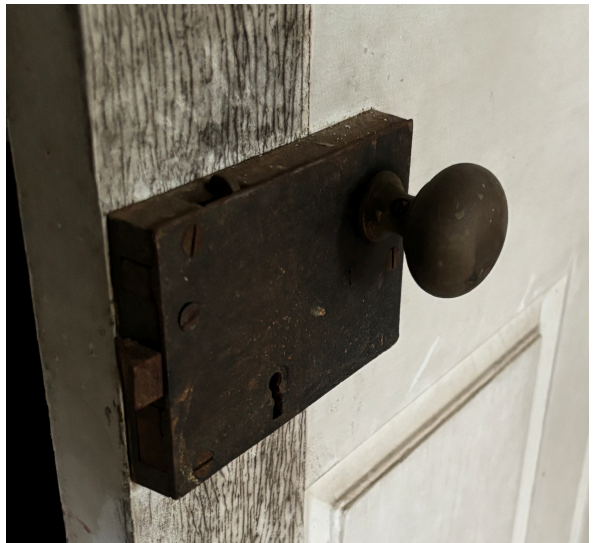
Figs. 39-44. A selection of hardware from throughout the house. Current photos.
